CP2006 - 3rd Street SW Bridge Decks

BRIDGE INSPECTION REPORT

Bridge No. AUBURN12 **Page 1 of 3** **Structure Type**
Bridge Name 3rd St SW/SB Off Ramp **Route** 01080 **Intersecting** C ST SW
Structure ID 08719300 **MilePost** 1.01 **Location** 0.3 West of Hwy 18

City of Auburn – 3rd St SW/SB Off-ramp No. Auburn12 Inspected October 20, 2010

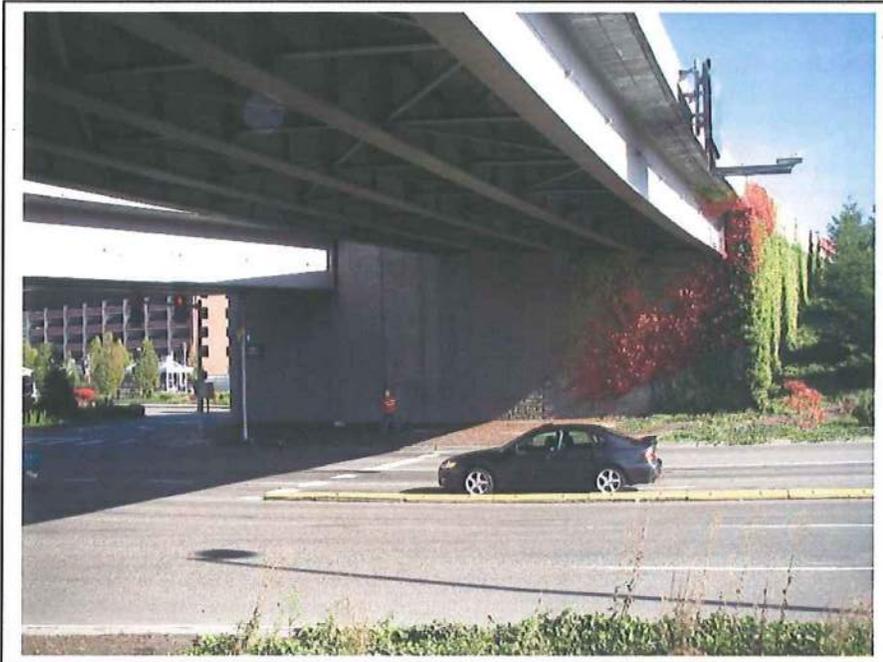
Looking east to abutment 2.

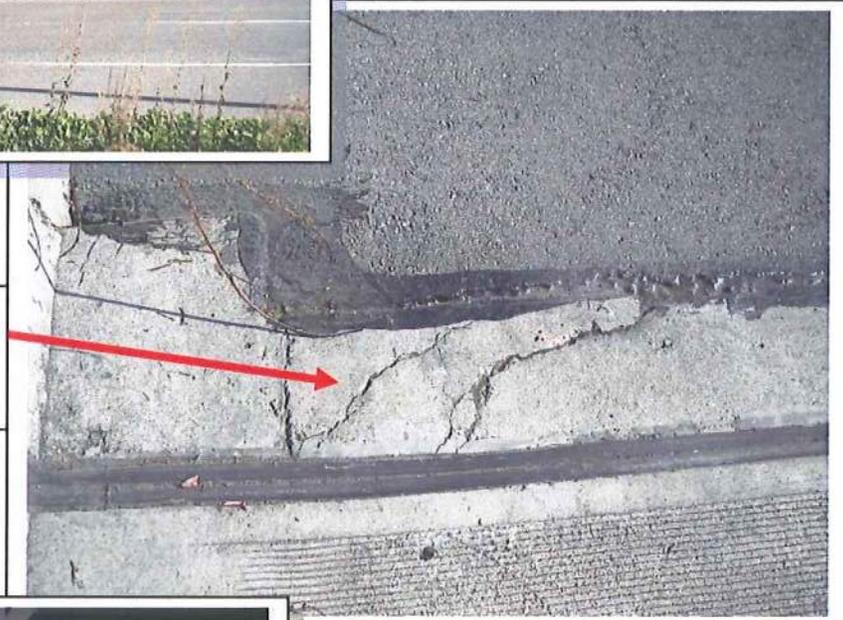
Heavy cracking and spalls in east header at the north end near the rail.

Cracks in concrete header at east joint north end.

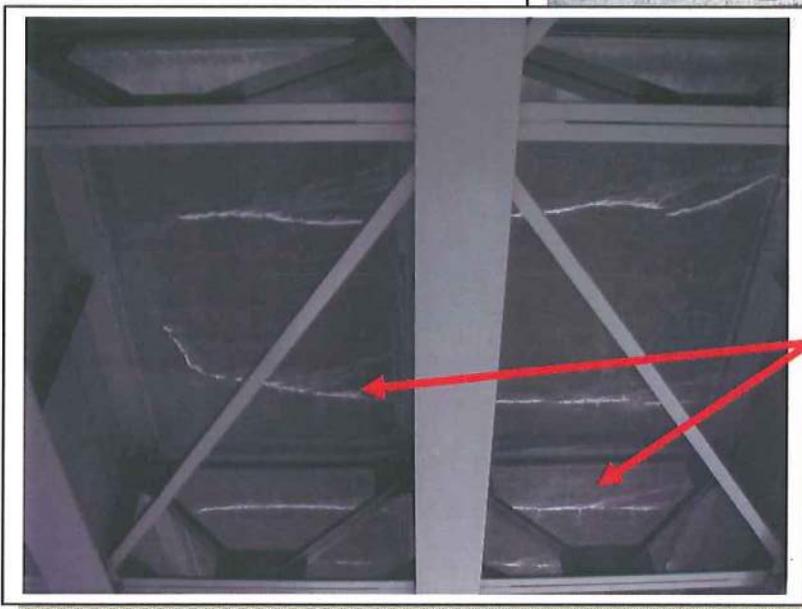
DECK SOFFIT: Heavy leaching transverse cracks spaced 2' -3'. Some longitudinal cracks beginning to extend off of transverse cracks.

Transverse leaching cracks throughout deck soffit.

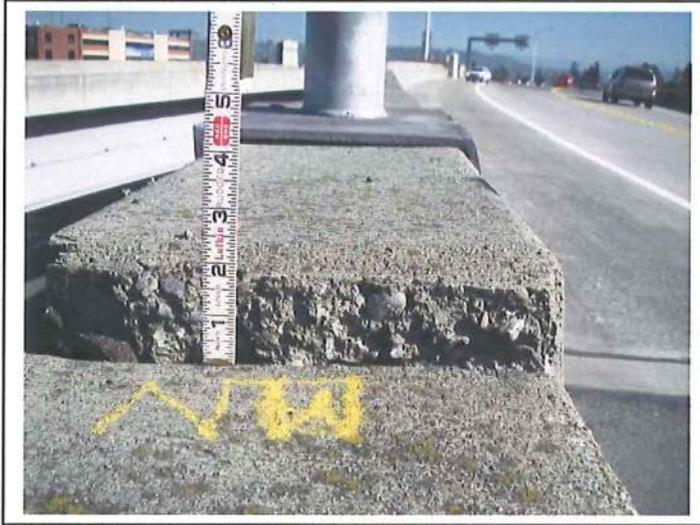
The retaining wall at the NW, SW and SE corners of the bridge shows signs of settlement and rotation at the joint with the curtain wall. The settlement is reflected on the concrete barrier rail. Notable spalling on the SE approach rail. Ivy obscures SE and SW retaining walls.

NW corner rail settlement up to 2".

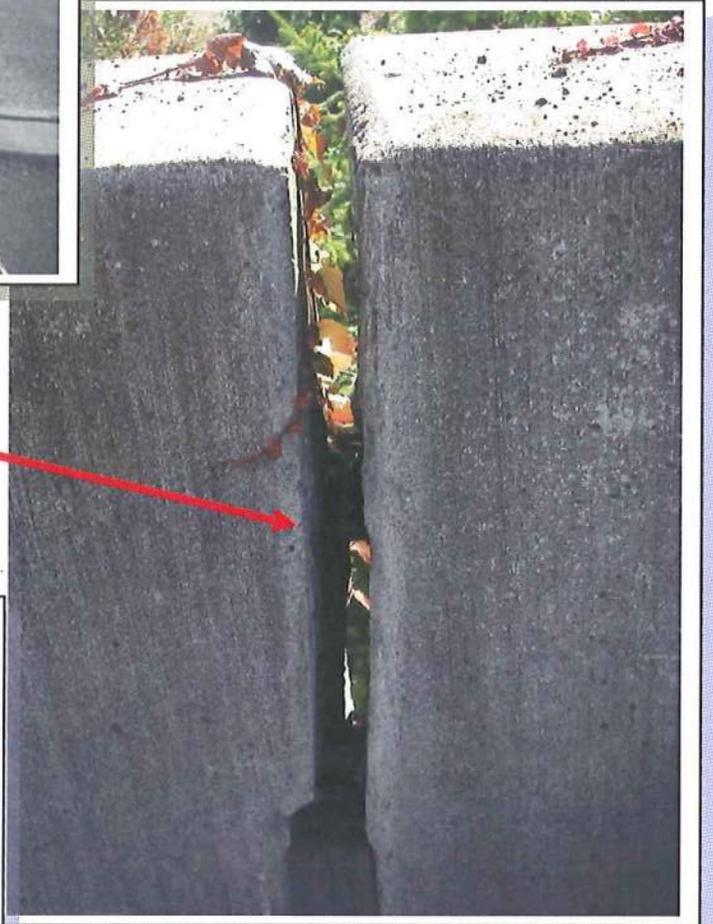
Open gap 2.5", some spalling at SW corner rail.

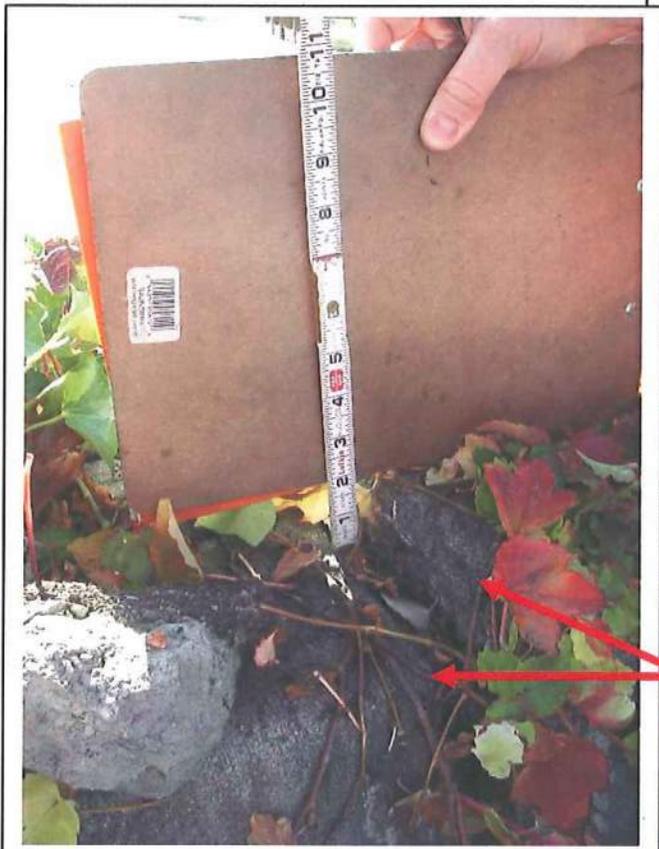
SE corner rail settlement up to 2" with spalling at rail joint.

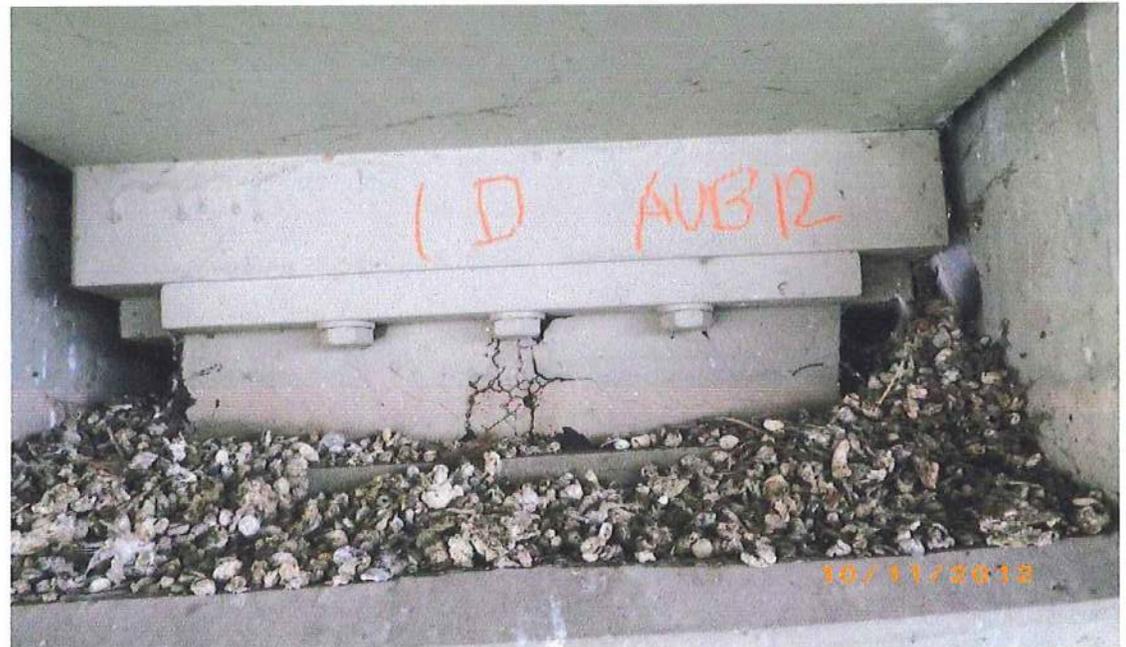
Bearing 1D with surrounding area buried in pigeon guano.

Repair No	Pr	R	Repair Description	Date Noted	Verified
10000	1	B	WASHING: Steel girders and bearings are covered in deep piles of pigeon guano. Thoroughly flush flanges, diaphragms, and bearings. Spot paint where necessary after paint system is visible.	10/24/2012	
10002	1	B	DECK OVERLAY: Deck is cracked throughout with thick white leaching cracks in soffit. Migration of water through deck will start rusting the top flanges of the steel girders. Install two-coat epoxy/aggregate overlay to seal deck and protect steel.	10/24/2012	
10003	2	B	BIRDS: Heavy accumulation of pigeon guano on steel flanges, cross bracing, and bearings. Terminate birds.	10/24/2012	
10001	M	M	MONITOR: Settlement at approaches. Monitoring point set at SE approach rail	10/24/2012

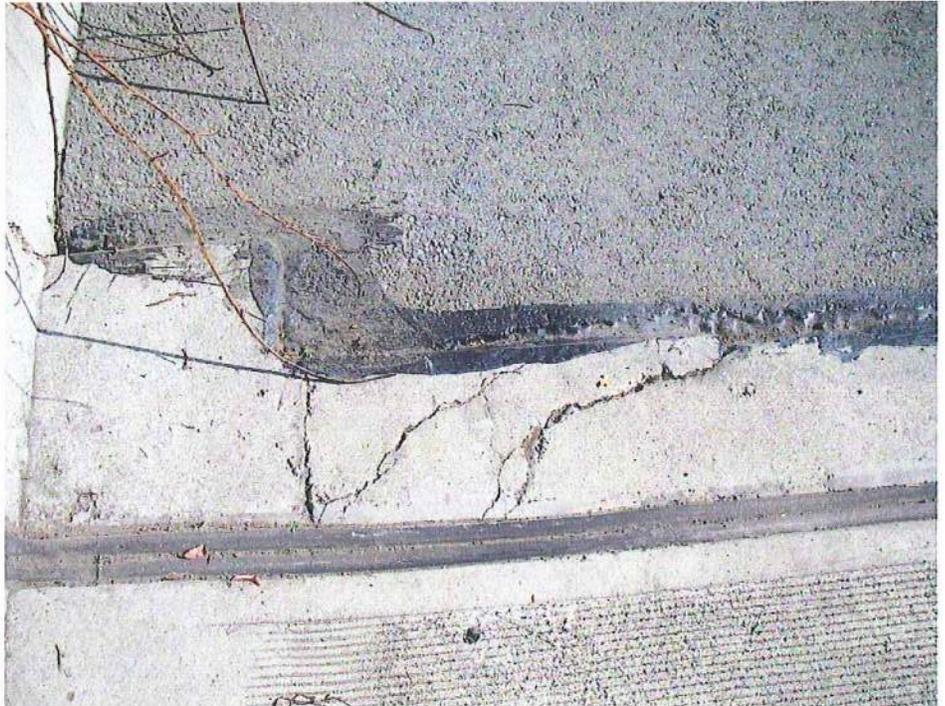
EJ Header @ P2

Cracked header at Pier 2 expansion joint at North end

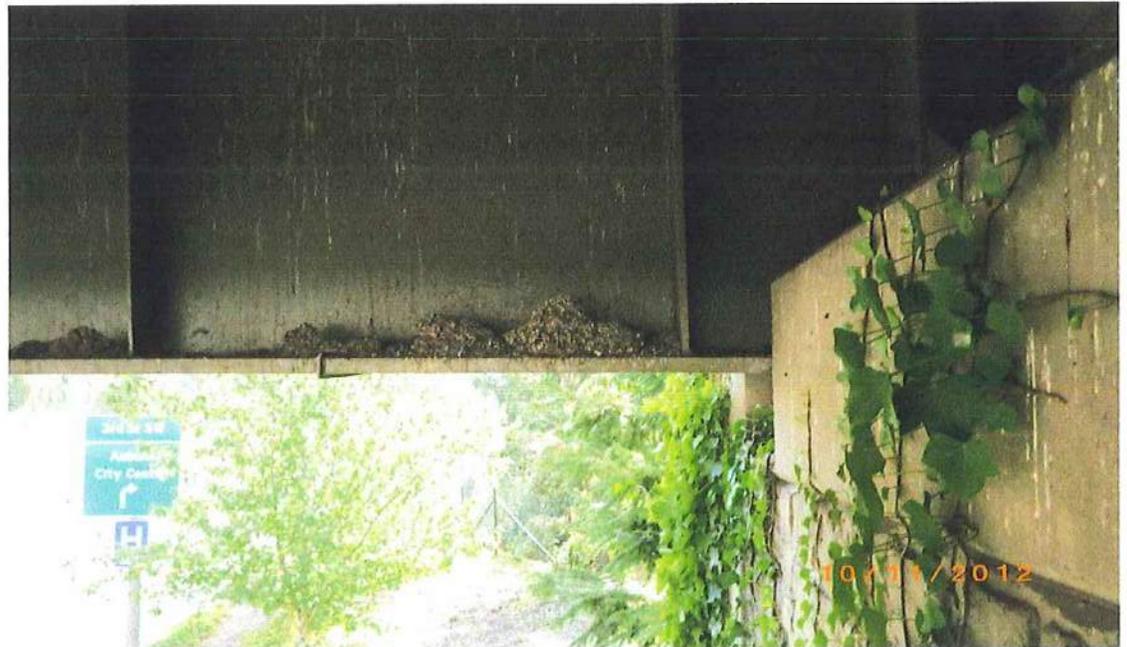
Girder 1E @ P1
Photographs
Photo Type: G - General
Orientation: S
Dates:
Repairs: 10000, 10003
Guano accumulation on bottom flanges.

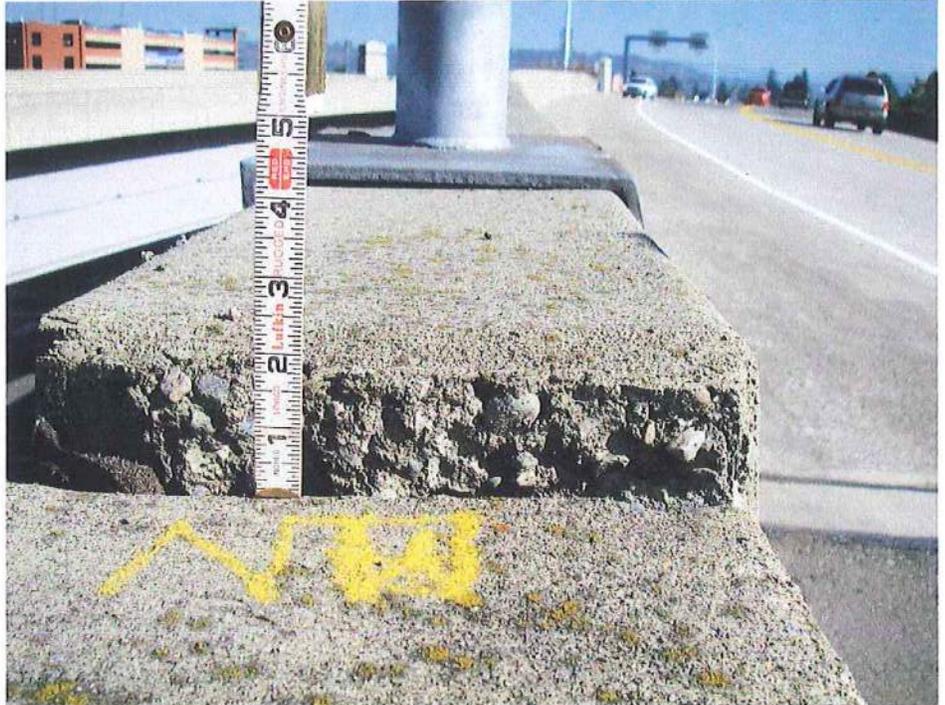
Rail Top @ NW

Photographs
Photo Type: G - General
Orientation: E
Dates: 10/20/2010
Repairs:
Vertical and horizontal offsets in rail top at NW corner. MONITOR for settling

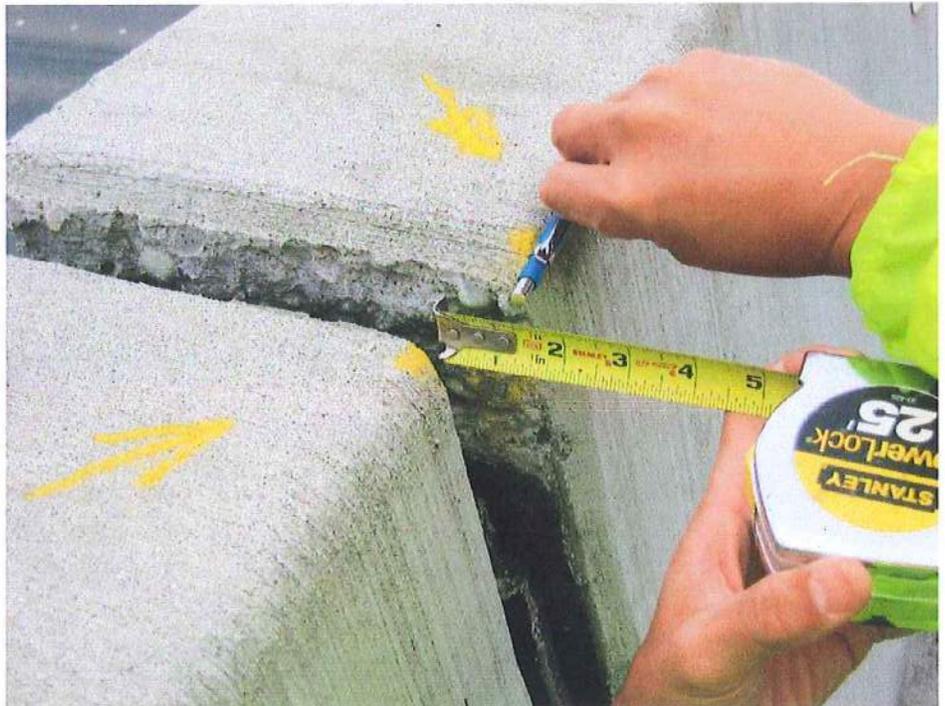
Rail top @ SE 2006

Photographs
Photo Type: M - Monitor
Orientation: DN
Dates: 10/17/2006
Repairs: 10001
Vertical and horizontal offsets in rail top. MONITOR for settling

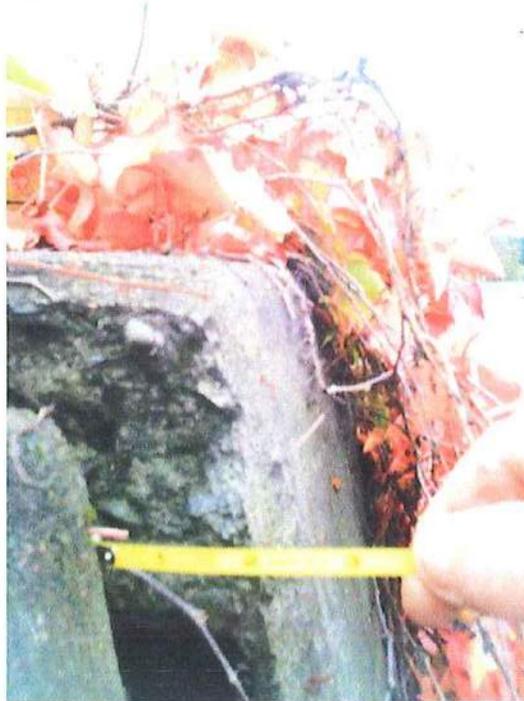
Vertical and horizontal offsets in rail top at Southeast corner. MONITOR for settling

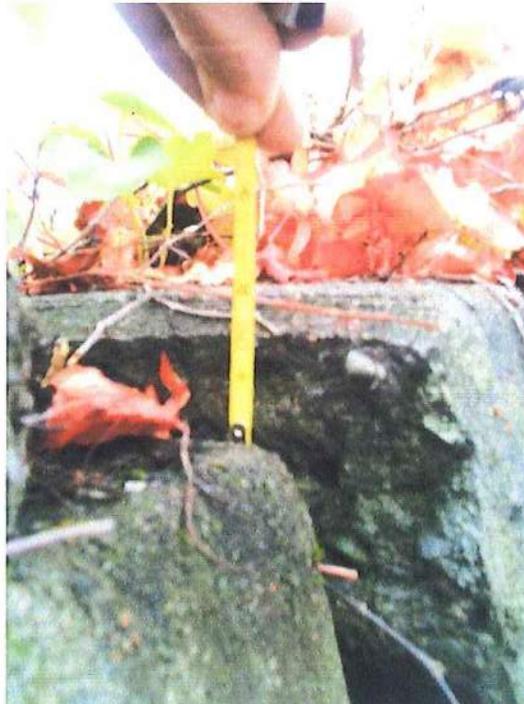
Rail top @ SE 2012 vertical

Vertical and horizontal offsets in rail top at Southeast corner. MONITOR for settling

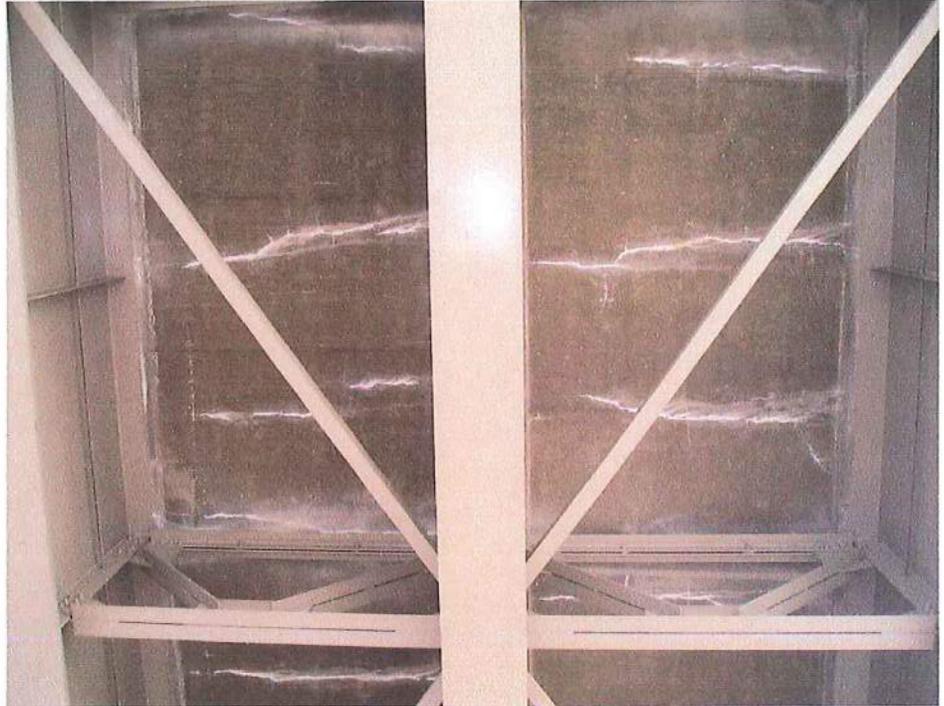
Transverse cracks throughout soffit

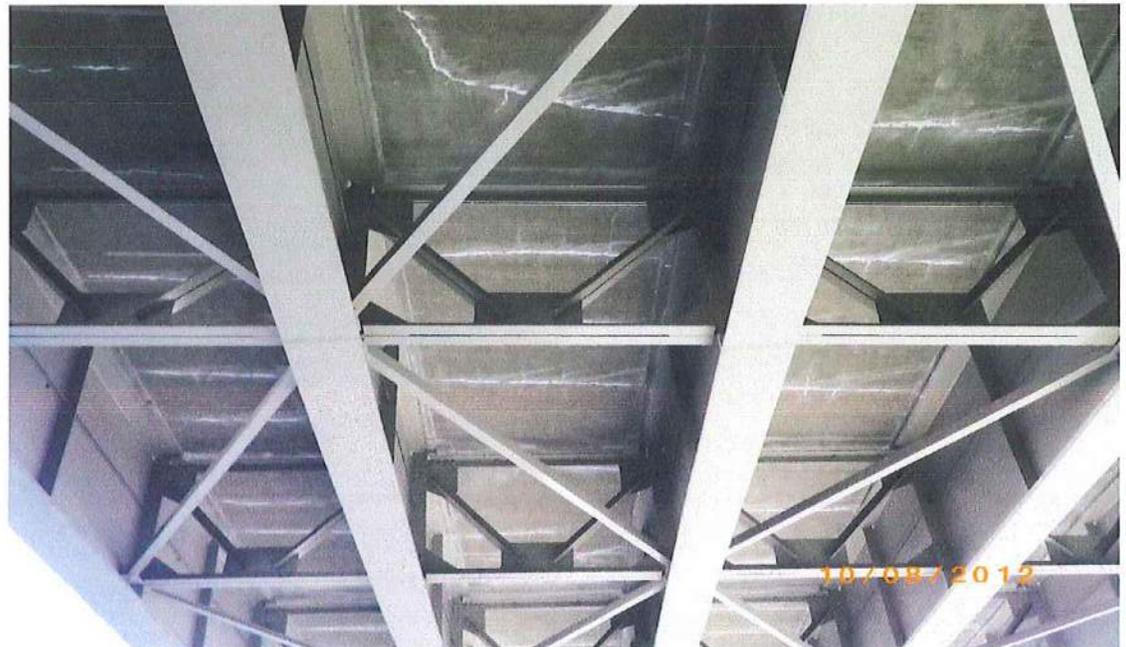
Soffit 2012

Transverse cracks throughout soffit

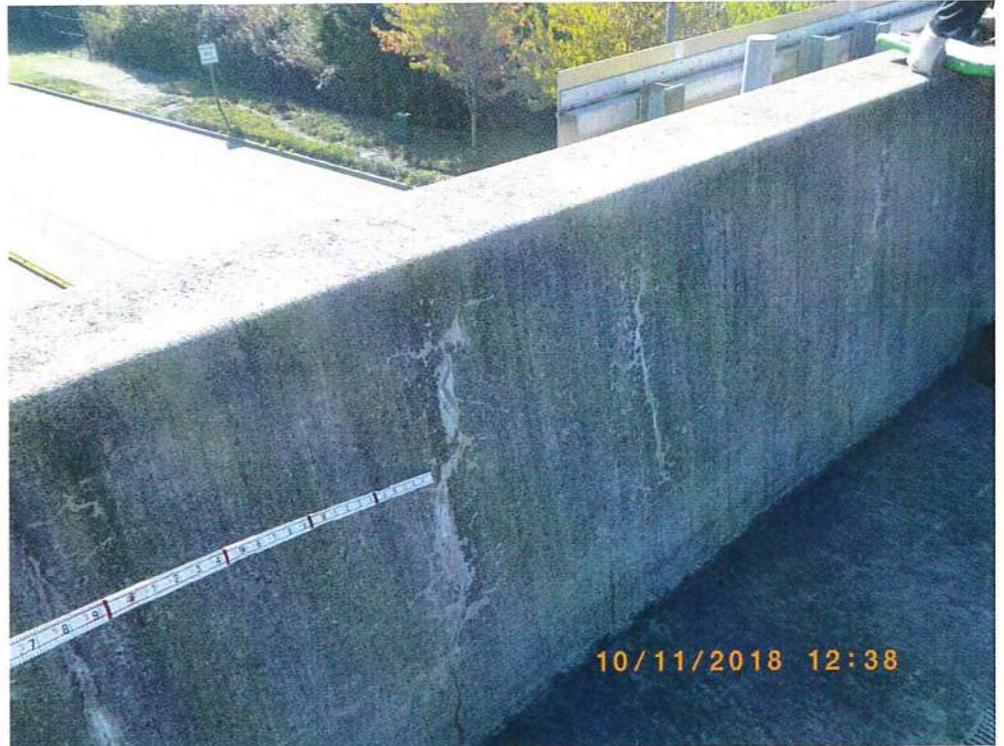
REMARKS: Vertical cracks in concrete railing

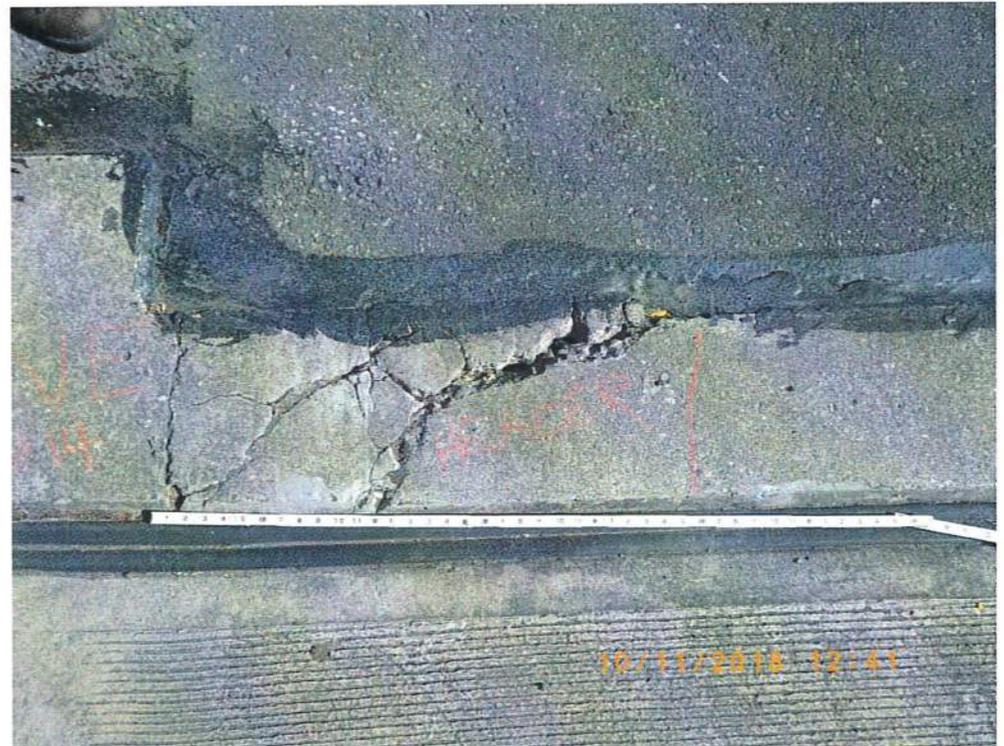
PHOTO
AUBURN12_10_1
1_2018_MAG (16)
HEADER (NE)

REMARKS: Cracked and spalled east header at north end near rail

Repairs						
Repair No	Pr	R	Repair Descriptions	Noted	Maint	Verified
10000	2	B	BRIDGE WASHING: Steel girders and bearings are covered in deep piles of pigeon guano. Thoroughly flush flanges, diaphragms, and bearings. Spot paint where necessary after paint system is visible.	10/24/2012		
10001	M	M	MONITOR: Settlement at approachs. Monitoring point set at SE approach rail	10/24/2012		
10002	3	B	DECK OVERLAY: Deck is cracked throughout with thick white leaching cracks in soffit. Migration of water through deck will start rusting the top flanges of the steel girders. Install two-coat epoxy/aggregate overlay to seal deck and protect steel.	10/24/2012		
10003	2	B	BIRDS: Heavy accumulation of pigeon guano on steel flanges, cross bracing, and bearings. Terminate birds.	10/24/2012		
10004	2	B	JOINT: Concrete headers are cracked. Repair	12/11/2014

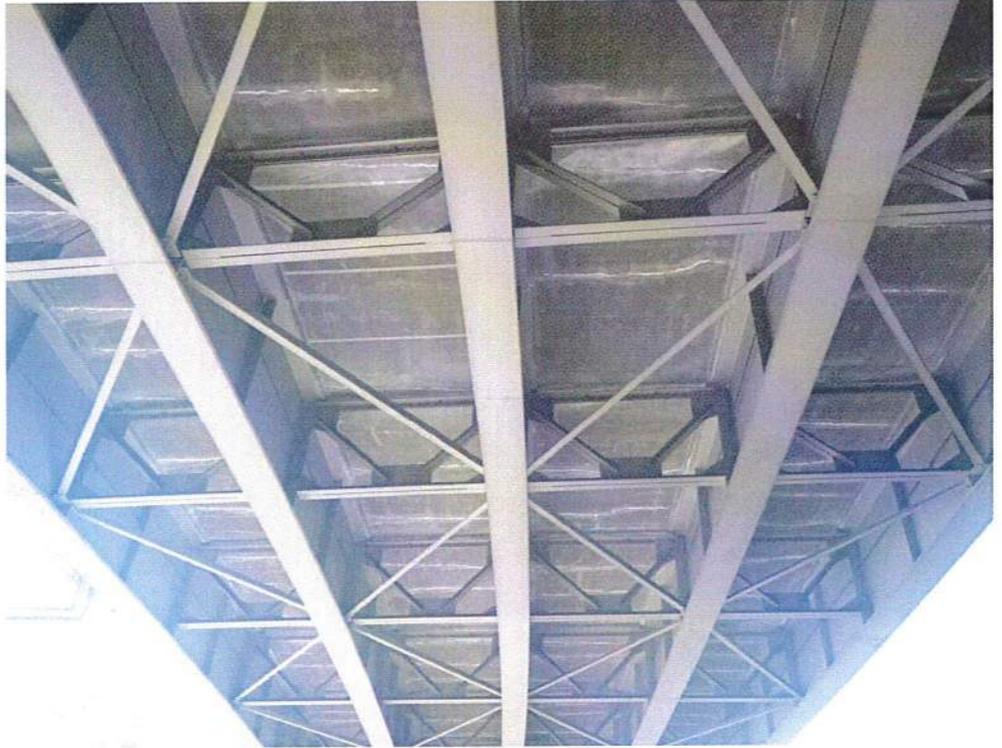
REMARKS: Transverse leaching cracks
in soffit

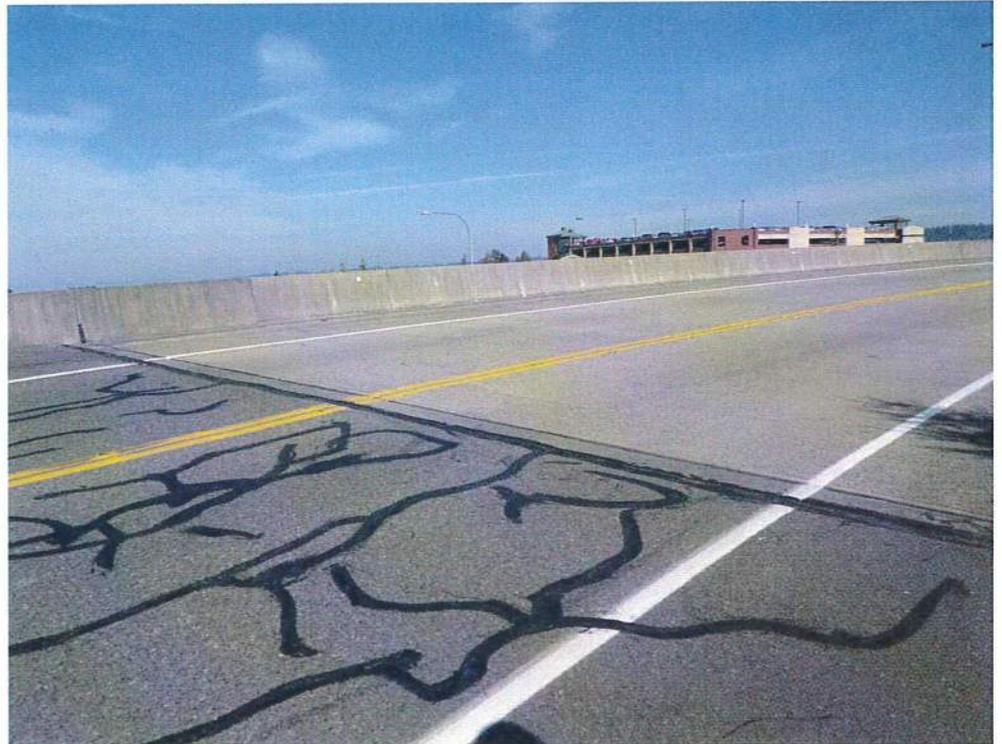
PHOTO
AUBURN12_10-11
-2018_HP (14)
APPROACH (W)

REMARKS: West approach sealed
cracks

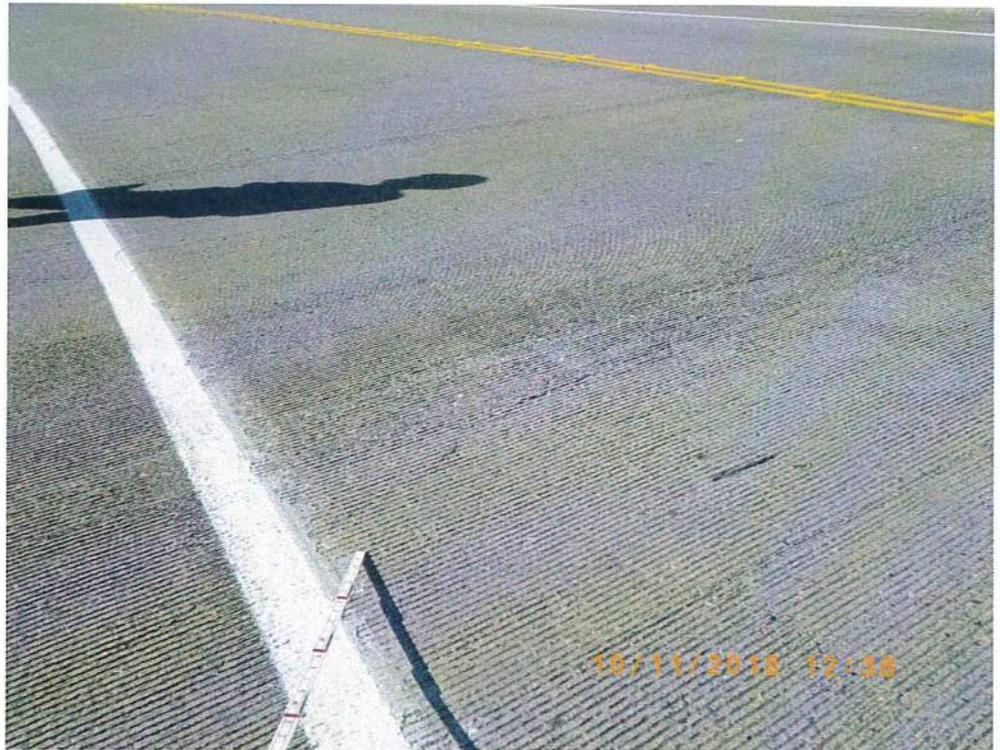
PHOTO
AUBURN12_10_1
1_2018_MAG (14)
DECK CRACKS

REMARKS: Transverse cracks in deck

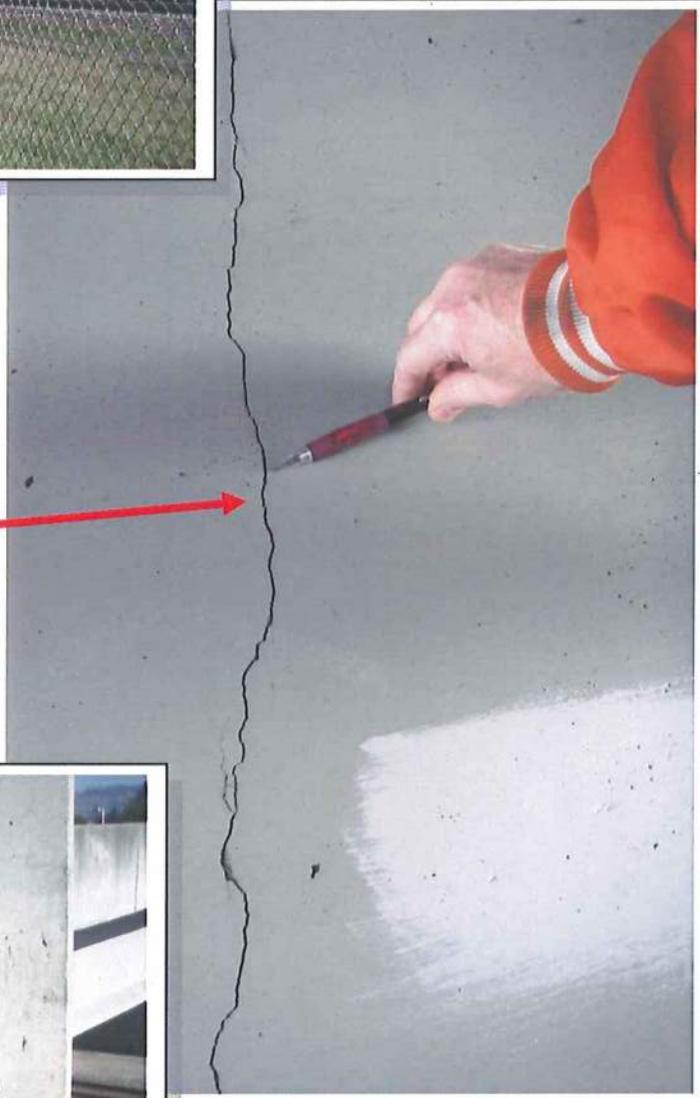
Vertical cracks in both abutment walls; many are full length.

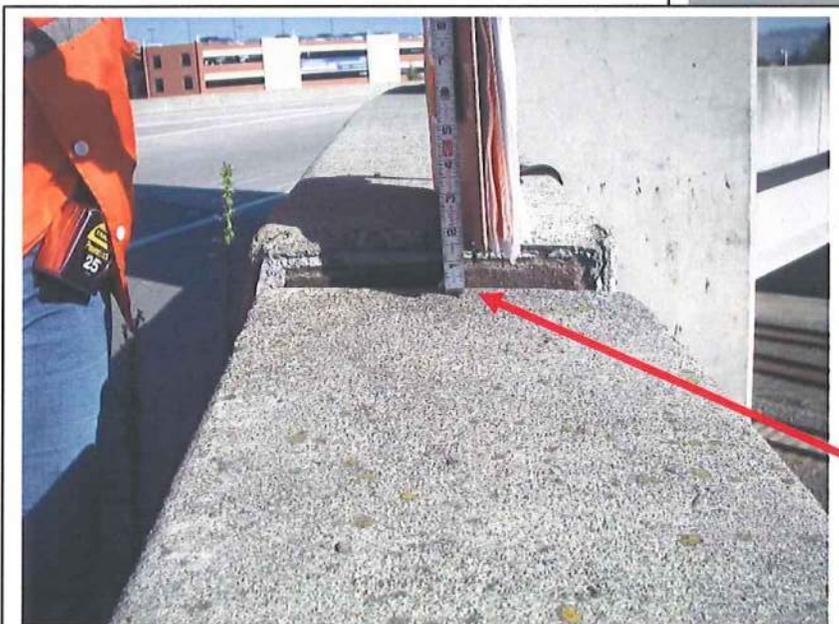
Settlement at SW corner up to 2" in bridge rail.

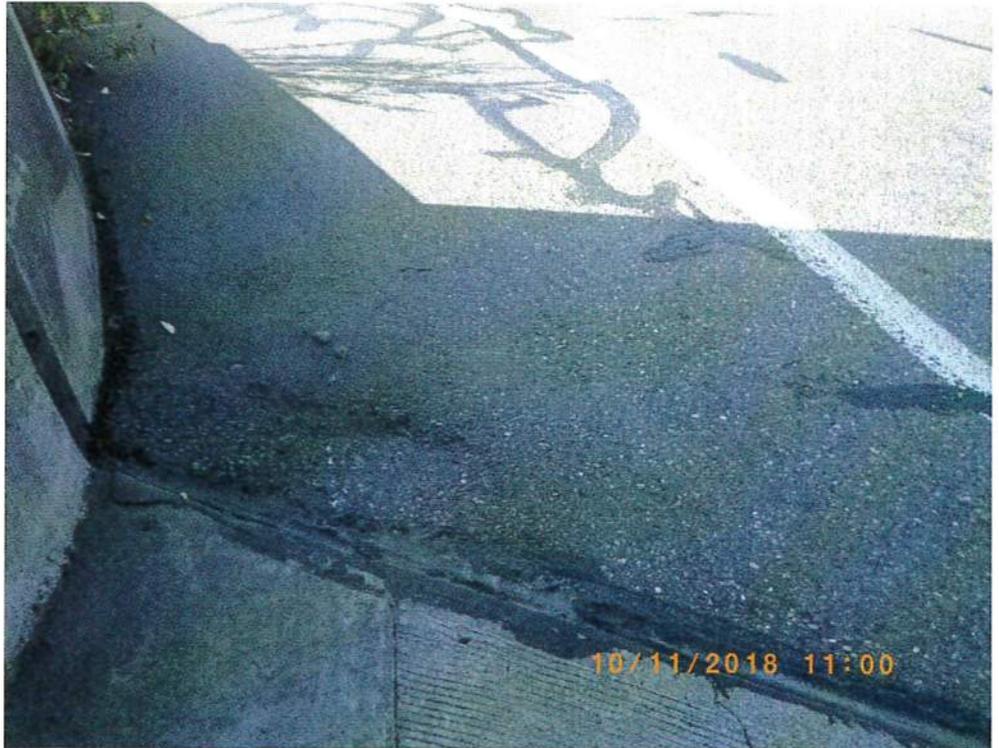
REMARKS: Sinkhole at SW approach

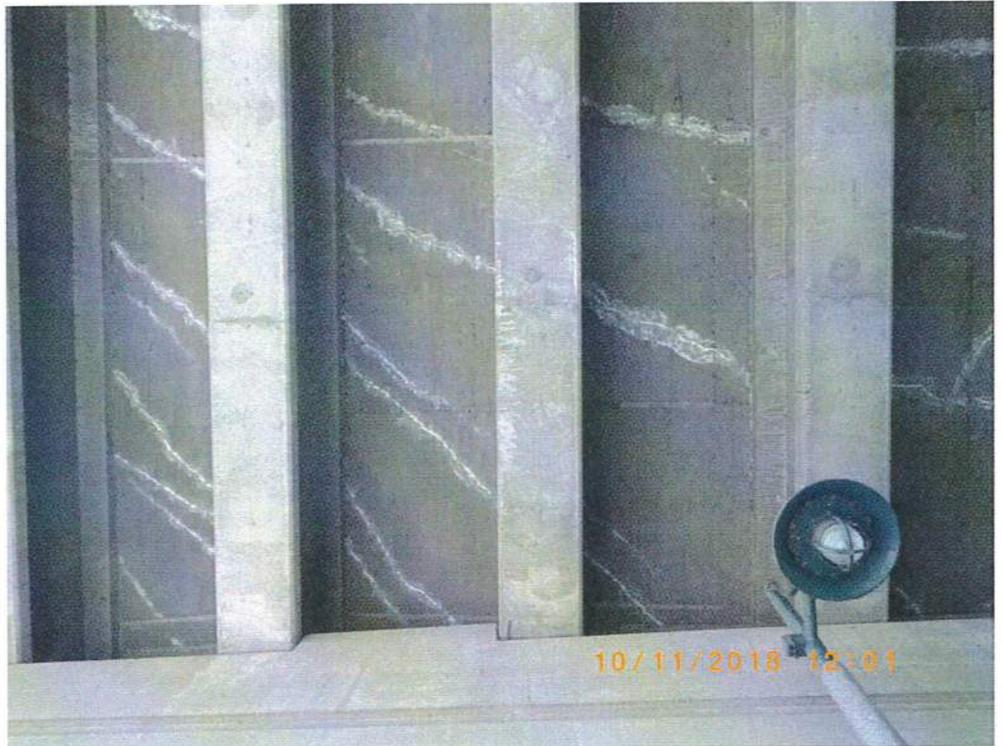
REMARKS: Soffit leaching crack

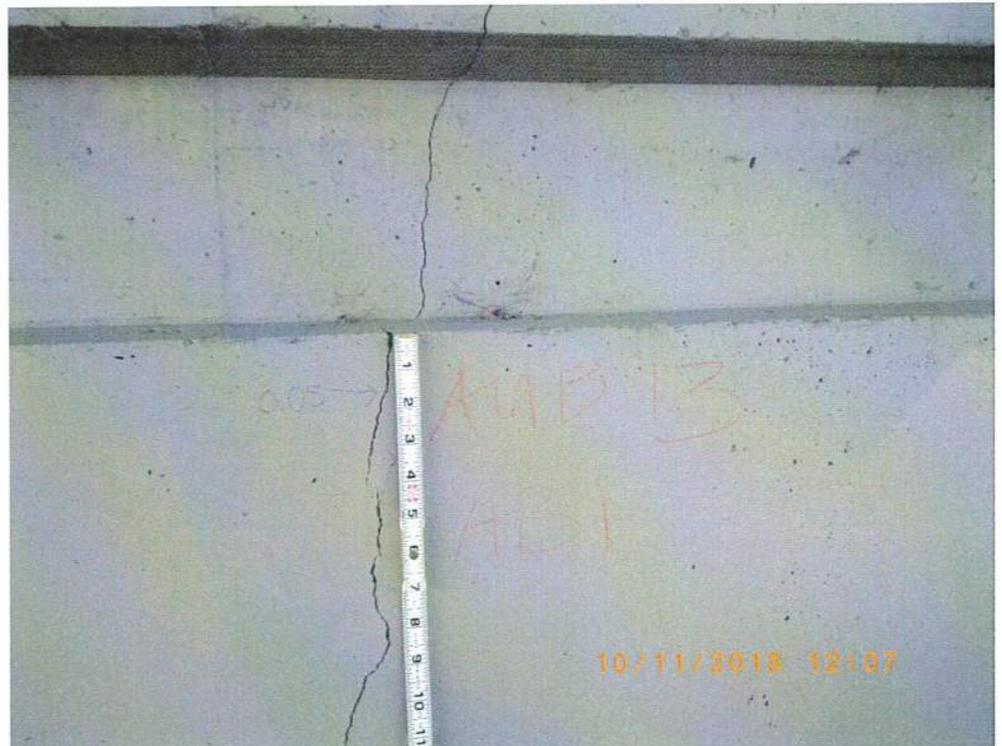
PHOTO
AUBURN13_10_1
1_2018_MAG (36)
ABUTMENT
CRACKS

REMARKS: 0.05" vertical crack at
abutment 1

Repair No	Pr	R	Repair Description	Date Noted	Verified
10000	1	B	DECK OVERLAY: Concrete deck has many transverse and diagonal cracks through to soffit. Shot blast clean the deck surface. Apply two-coat epoxy overlay with 6x10 aggregate.	10/24/2012	
10001	M	M	MONITOR: Vertical cracks in abutments and deck cracking	12/18/2012

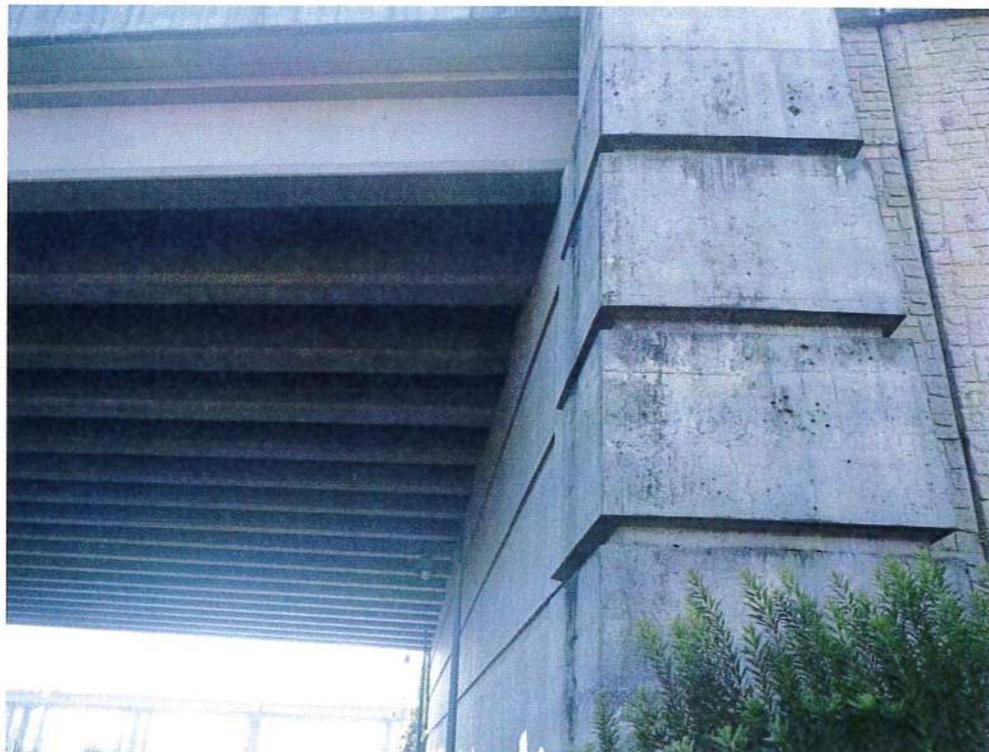
PHOTO
AUBURN13_10-11
-2018_HP (11)
TOWER (NW)

REMARKS: Typical map cracking on towers, NW tower shown

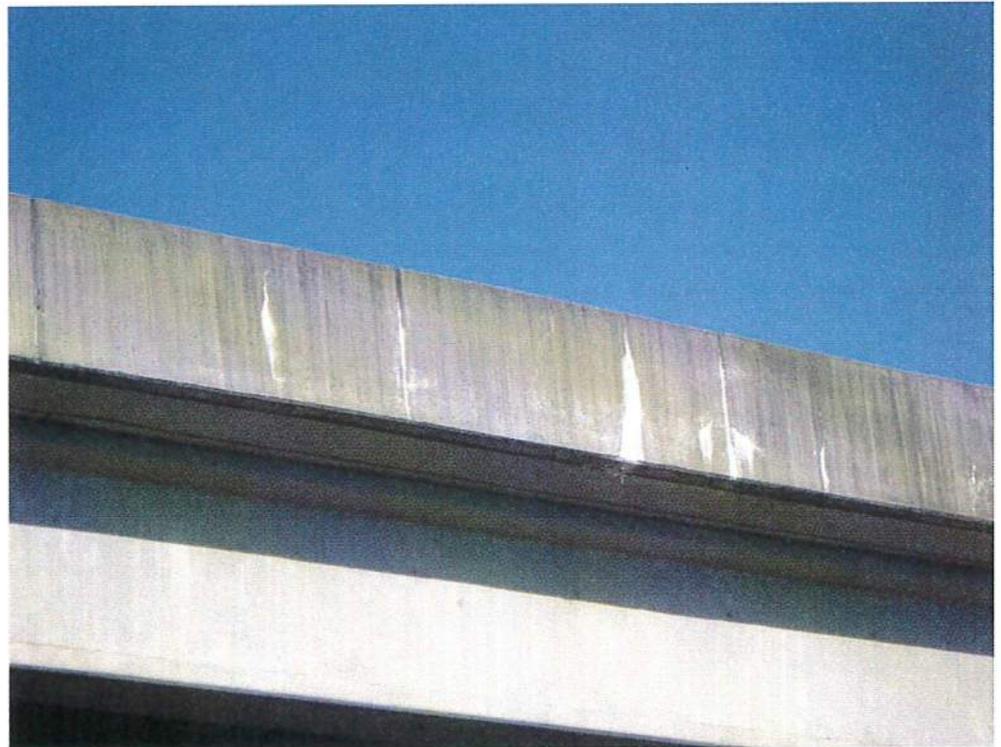
PHOTO
AUBURN13_10-11
-2018_HP (16)
RAIL CRACKS

{root}
Photo Type: G - General
Orientation: N
Date: 10/11/2018
Repairs:
REMARKS: Leaching crack in south exterior rail

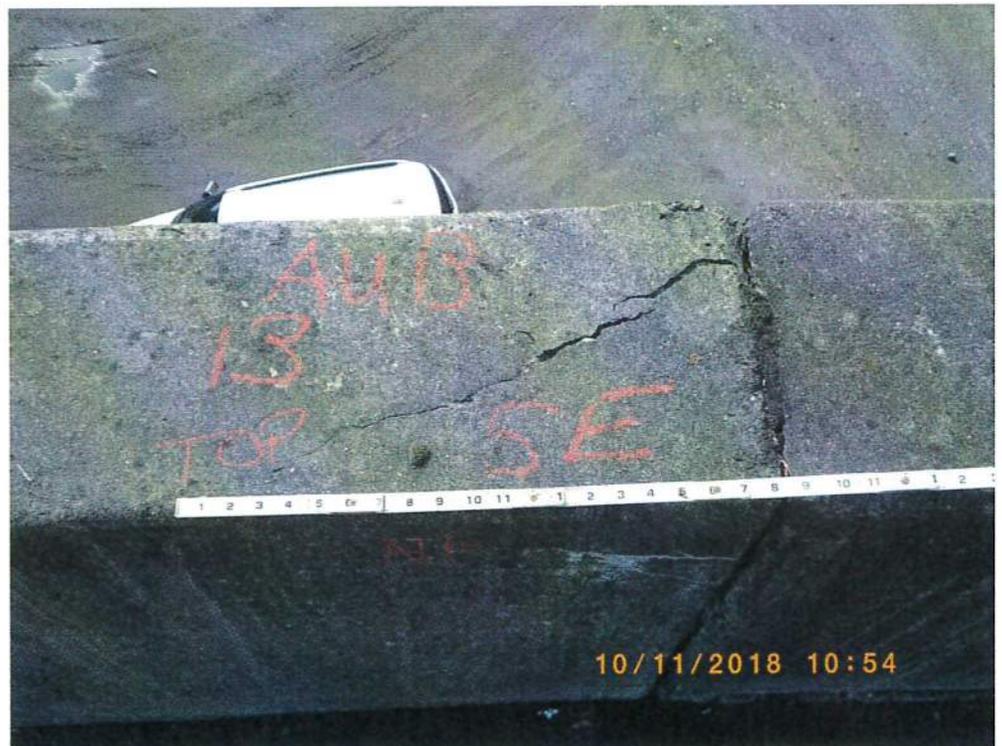
PHOTO
AUBURN13_10_1
1_2018_MAG (10)
APPROACH RAIL

REMARKS: Cracks on SE approach rail

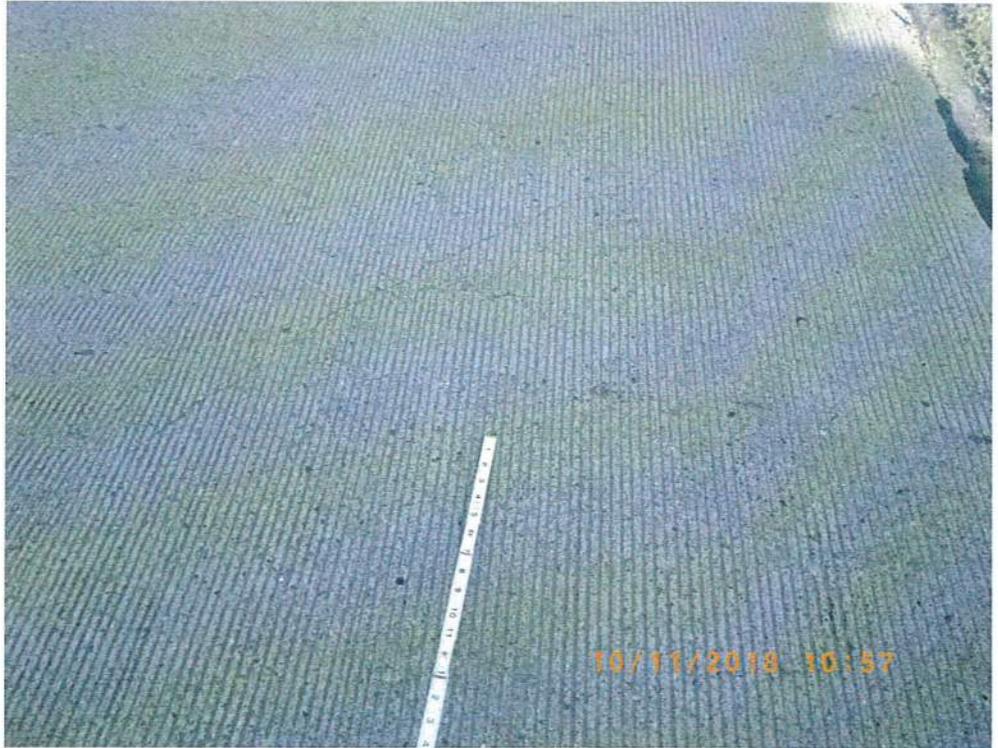
REMARKS: Open diagonal deck cracks
