Bowman Creek Flow Monitoring

Investigator: Maggie Gipson

Date: 11-12-15

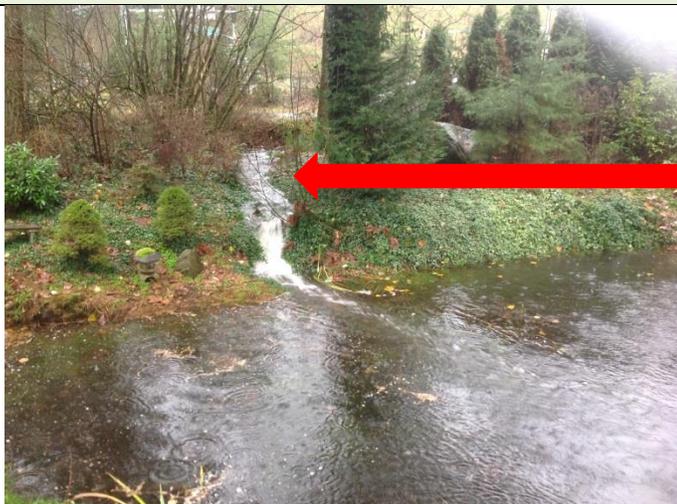
12-8-15

Input from storm water culvert. Water flowing from the west, traveling under Kersey Way SE, and then discharging into Fassbind pond.

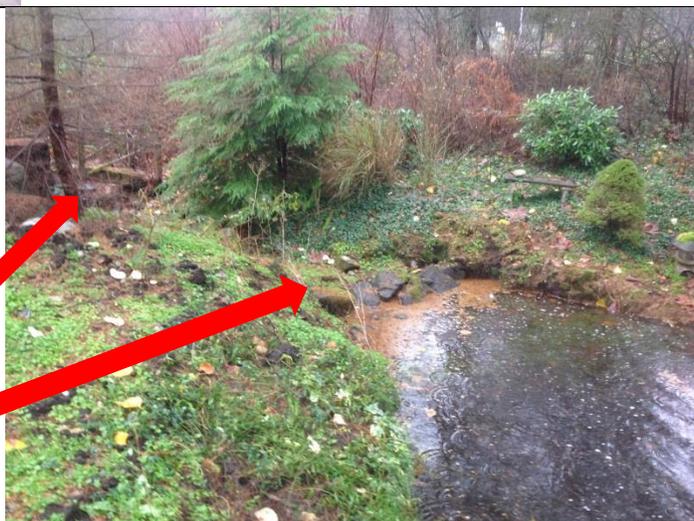
Dry Bowman Creek channel discharging to Fassbind pond. No water from Bowman creek contributing to the pond level.

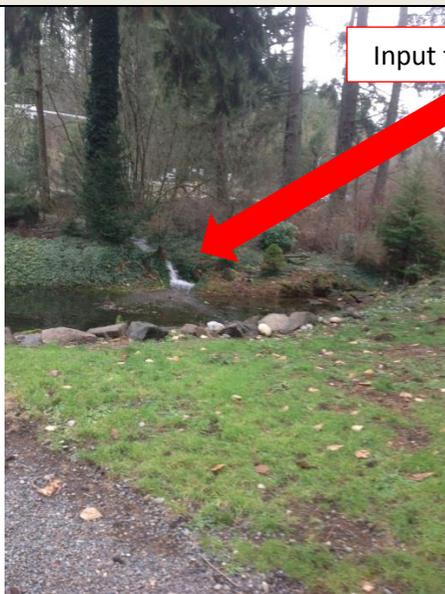
12-22-15

Input from storm water culvert.

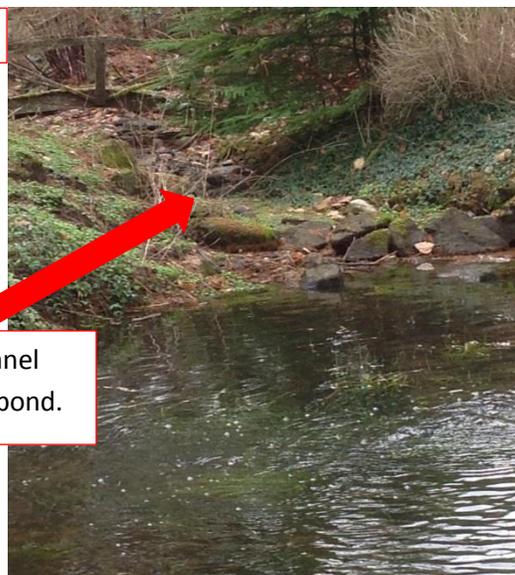
Dry Bowman Creek channel discharging to Fassbind pond.

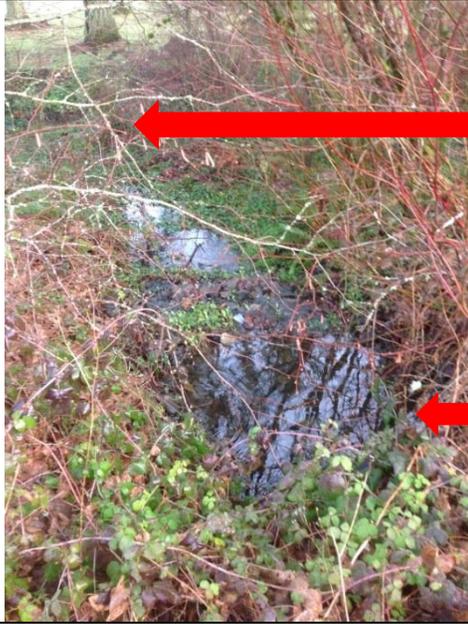
1-6-16

Fassbind pond.

Input from storm water culvert.
Water flowing from the west,
traveling under Kersey Way SE, and
then discharging into Fassbind pond.

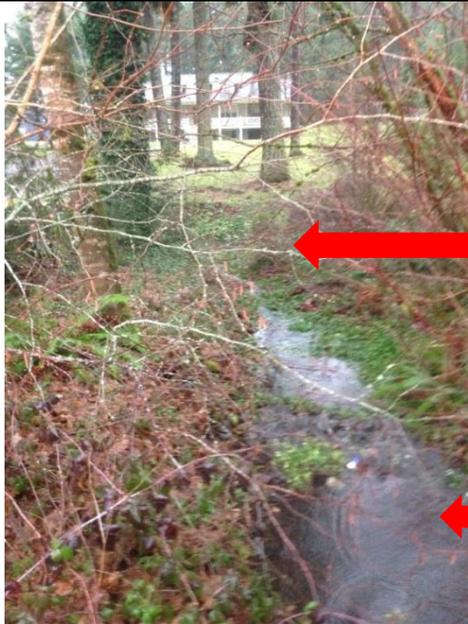
1-13-16

Fassbind pond.

Input from storm water culvert.
Water flowing from the west,
traveling under Kersey Way SE, and
then discharging into Fassbind pond.

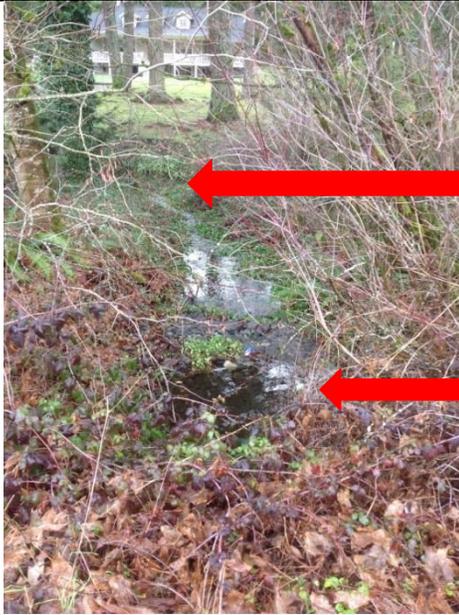
1-20-16

Fassbind pond.

Input from storm water culvert.
Water flowing from the west,
traveling under Kersey Way SE, and
then discharging into Fassbind pond.

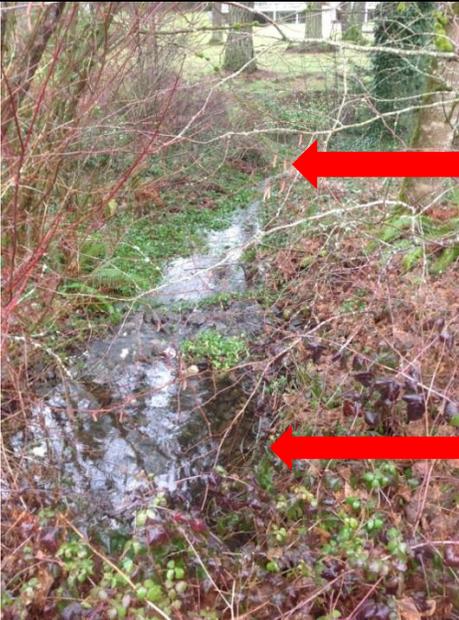
1-27-16

Fassbind pond.

Input from storm water culvert.
Water flowing from the west,
traveling under Kersey Way SE, and
then discharging into Fassbind pond.

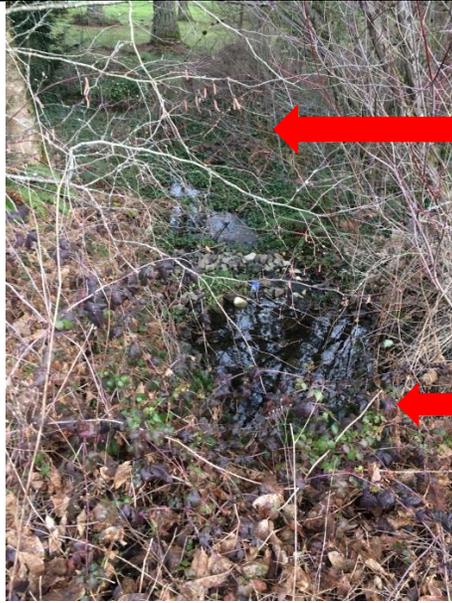
2-3-16

Fassbind pond.

Input from storm water culvert.
Water flowing from the west,
traveling under Kersey Way SE, and
then discharging into Fassbind pond.

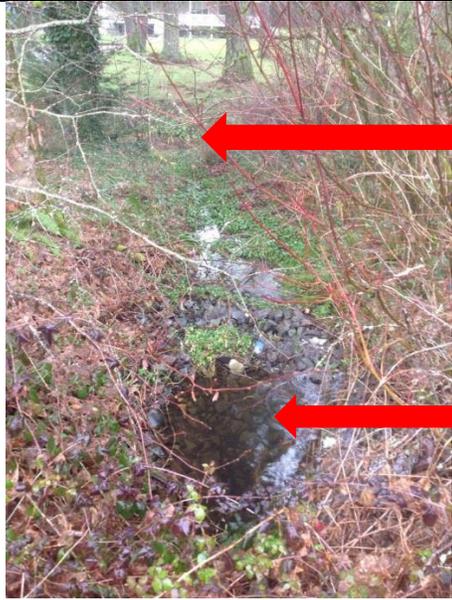
2-10-16

Fassbind pond.

Input from storm water culvert.
Water flowing from the west,
traveling under Kersey Way SE, and
then discharging into Fassbind pond.

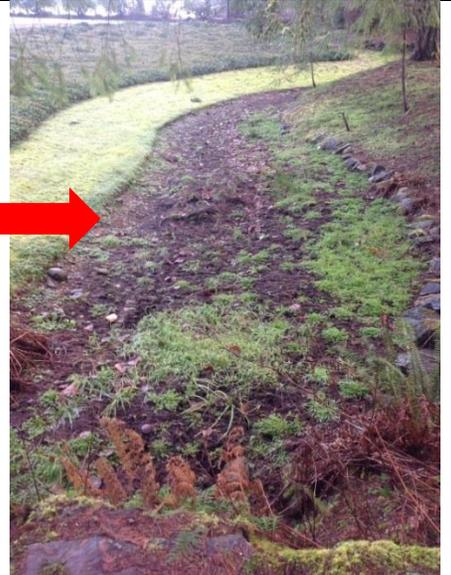
1-6-16

Dry Bowman Creek channel

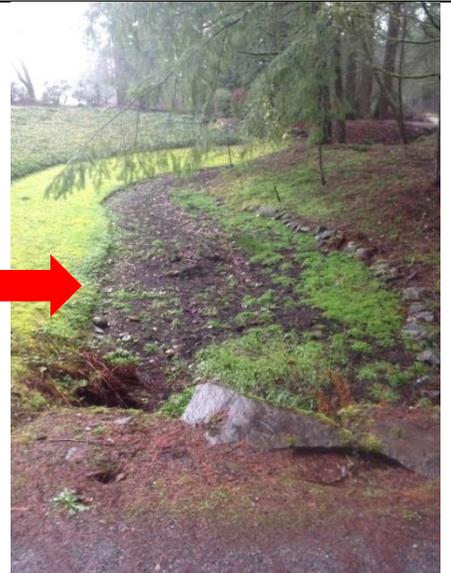
1-13-16

Dry Bowman Creek channel

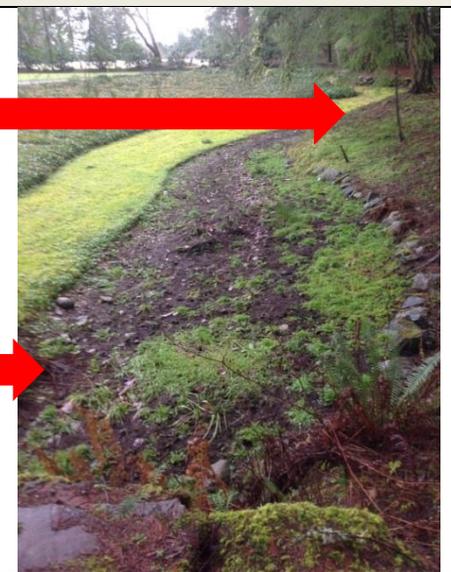
1-20-16

Flow stops around here

Dry Bowman Creek channel

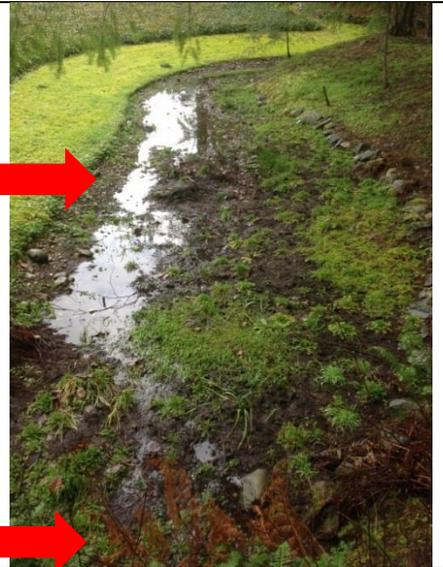
1-27-16

Some puddles of standing water in Bowman Creek channel.

Flow stops around here

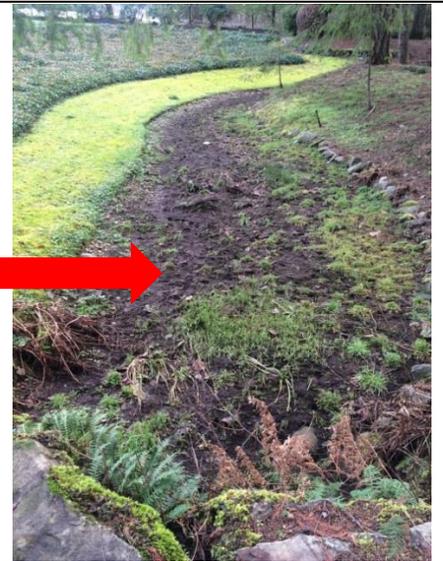
2-3-16

Dry Bowman Creek channel

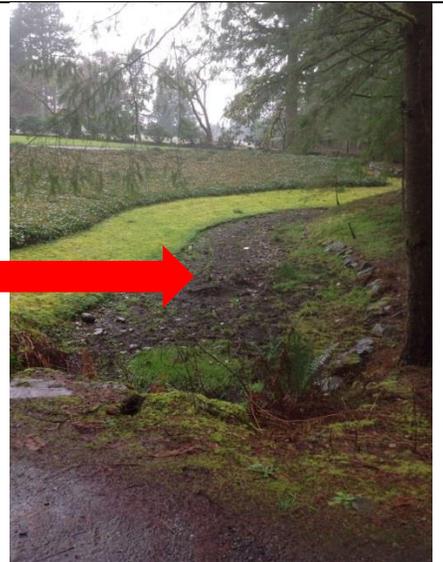
2-10-16

Dry Bowman Creek channel
