Bowman Creek Flow Monitoring

Investigator: Maggie Gipson

Date: 11-12-15

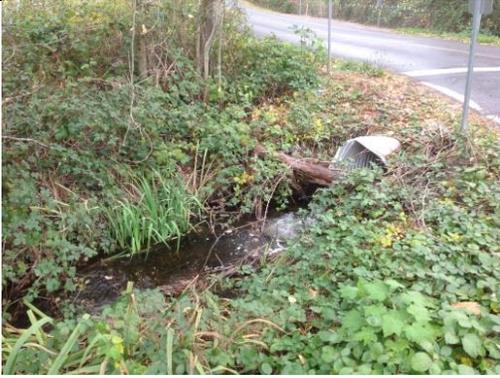
11-12-15

Location	Time	Flow Conditions	Observations
M1 Randall Ave SE	2:01pm	Strong Flow	Clear water flowing from culvert
M2 Katherine Ave SE	2:08pm	No Flow	Stream bed moist, but firm ground
M3 Jasmine Ave SE	2:17pm	No Flow	Stream bed moist, but firm ground
M4 Driveway	2:34pm	No Flow	Dry stream channel, contained leaf and stick debris
M5 Roadside APN 3221059026	2:29pm	No Flow	Dry stream channel, contained leaf and stick debris
M6 Mine Property	3:00pm	Flow	Channel had moving water

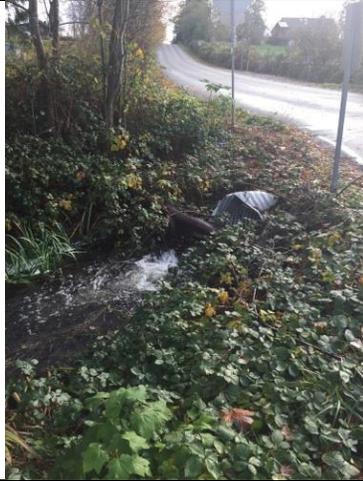
11-19-15

Location	Time	Flow Conditions	Observations
M1 Randall Ave SE	8:55am	Strong/ High flow	Water Clear, lots flowing form culvert
M2 Katherine Ave SE	9:03am	Flow, fast	Stream channel full, flowing, clear, some white foam
M3 Jasmine Ave SE	9:10am	Flow, slow	Channel full, water clear
M4 Driveway	9:15am	No Flow	Channel damp (saw one puddle)
M5 Roadside APN 3221059026	9:19am	No Flow	Channel damp (saw one puddle)
M6 Mine Property	9:30am	Flow, fast	Clear water flowing into culvert

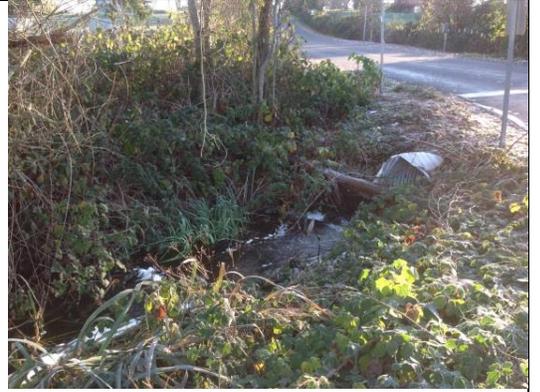
11-25-15

Location	Time	Flow Conditions	Observations
M1 Randall Ave SE	8:54am	Flow, fast	Water Clear, some white foam present
M2 Katherine Ave SE	9:02am	Flow	Moving clear water, white foam present
M3 Jasmine Ave SE	9:06am	Flow, not moving	Channel full, still, clear water
M4 Driveway	9:11am	No Flow	Stream channel dry
M5 Roadside APN 3221059026	9:19am	No Flow	Stream channel dry
M6 Mine Property	9:27am	Flow, fast	Clear water flowing into culvert
