CP2006 - 3rd Street SW Bridge Decks

BRIDGE INSPECTION REPORT

Bridge No. AUBURN12 **Page 1 of 3** **Structure Type**
Bridge Name 3rd St SW/SB Off Ramp **Route** 01080 **Intersecting** C ST SW
Structure ID 08719300 **MilePost** 1.01 **Location** 0.3 West of Hwy 18

City of Auburn – 3rd St SW/SB Off-ramp No. Auburn12 Inspected October 20, 2010

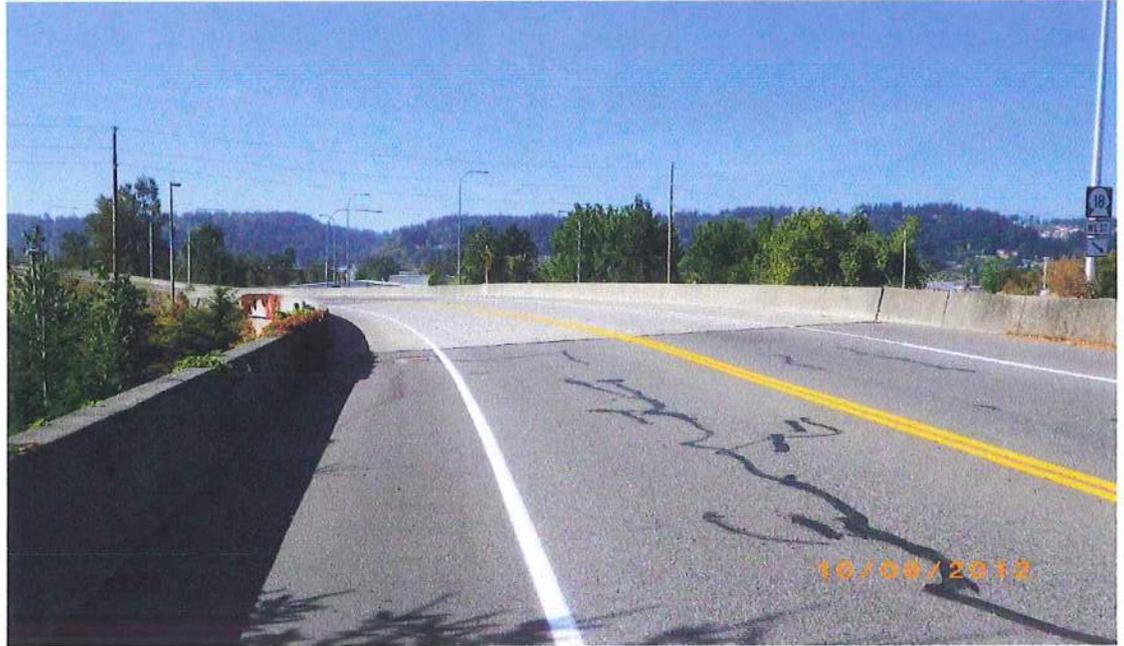
Deck looking West 2012

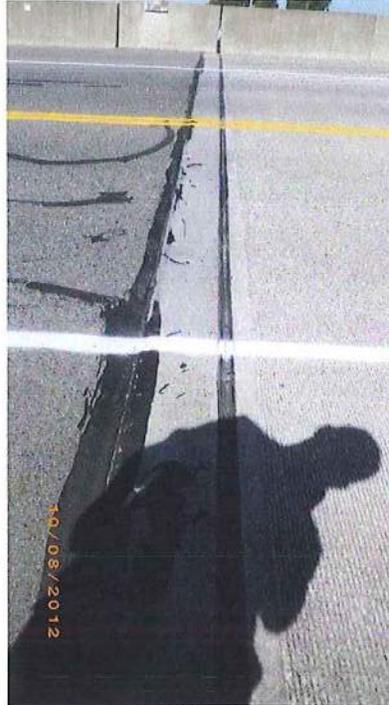
Expansion joint at Pier 1 looking North

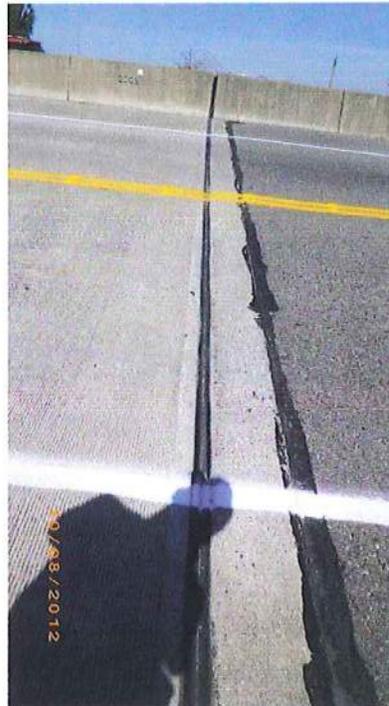
EJ@P2

Expansion joint at Pier 2 looking North

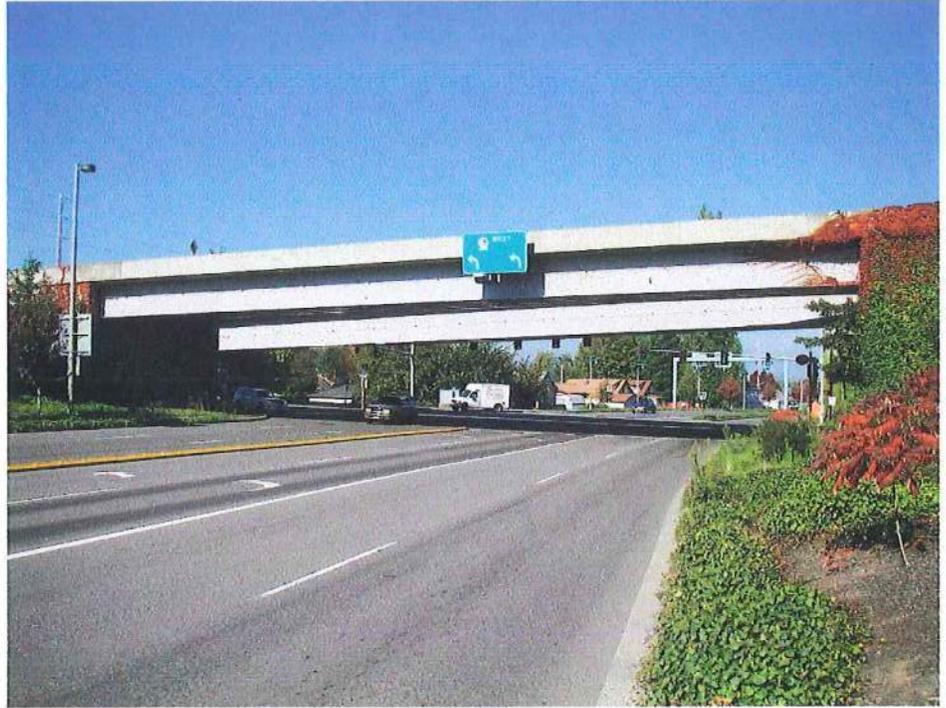
Elevation looking North 2010

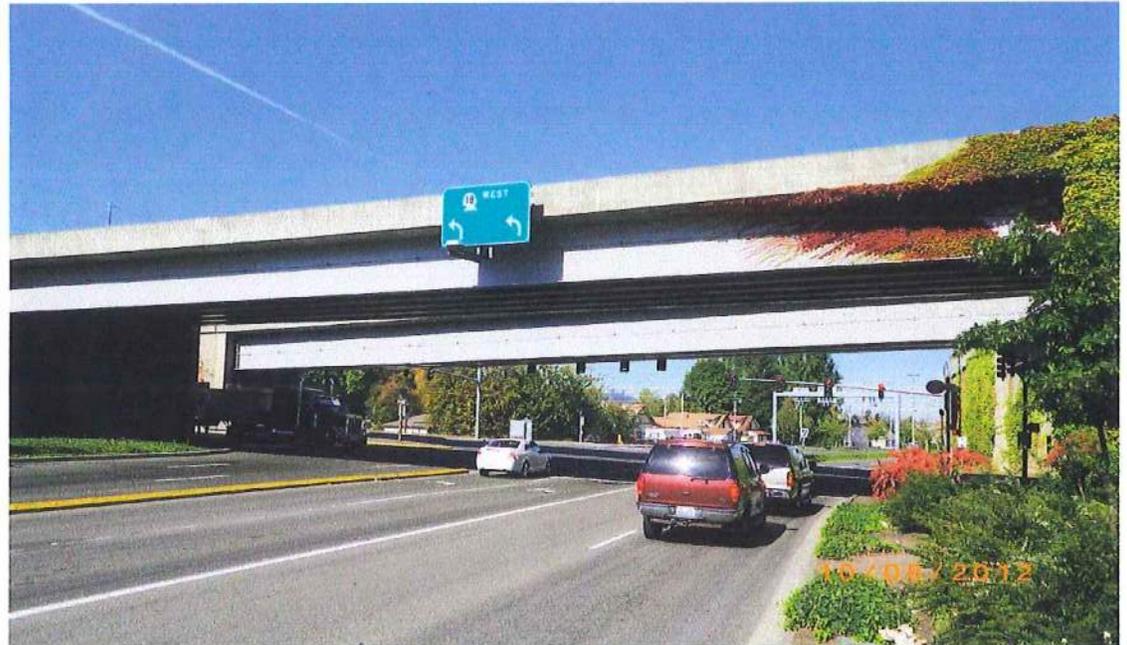
EL Ikg N 2012

Elevation looking North 2012

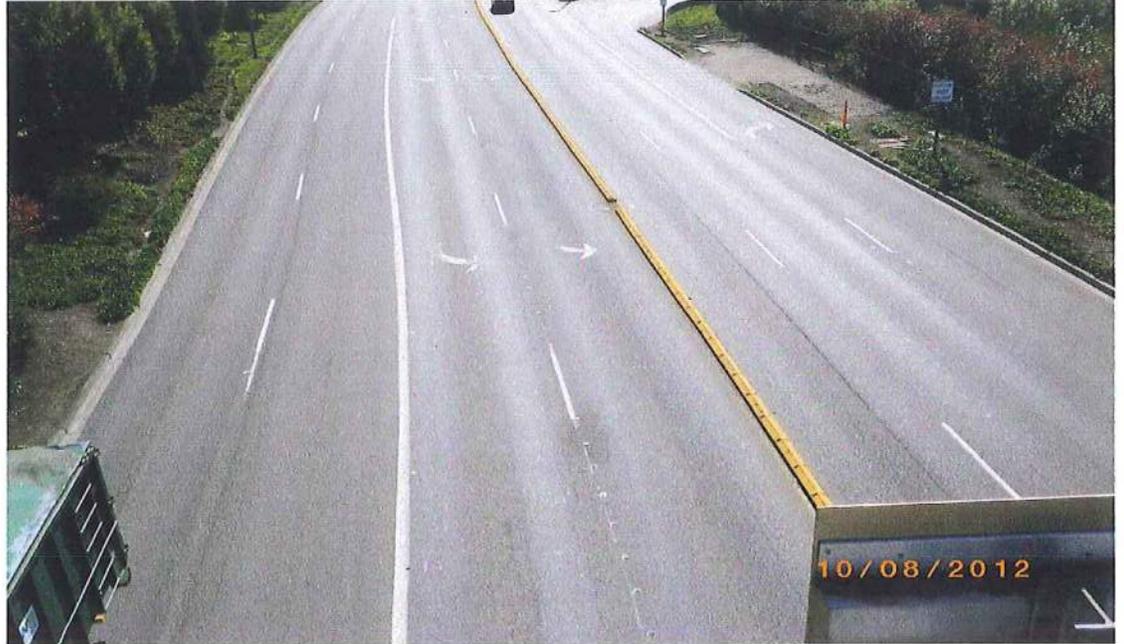
Four Northbound lanes and three Southbound lanes cross under the bridge.

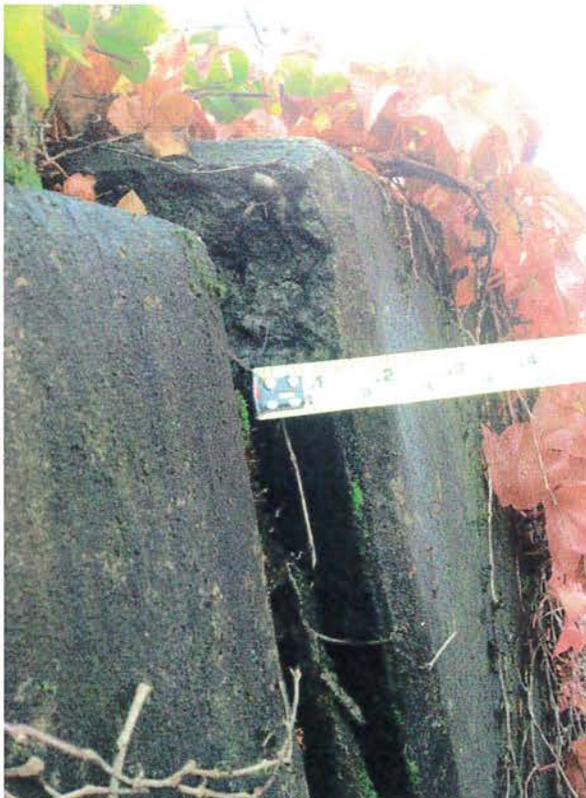
SE corner rail settlement up to 2" with spalling at rail joint.

Auburn 12 10242014 Traffic Barrier Rotation@SE Corner

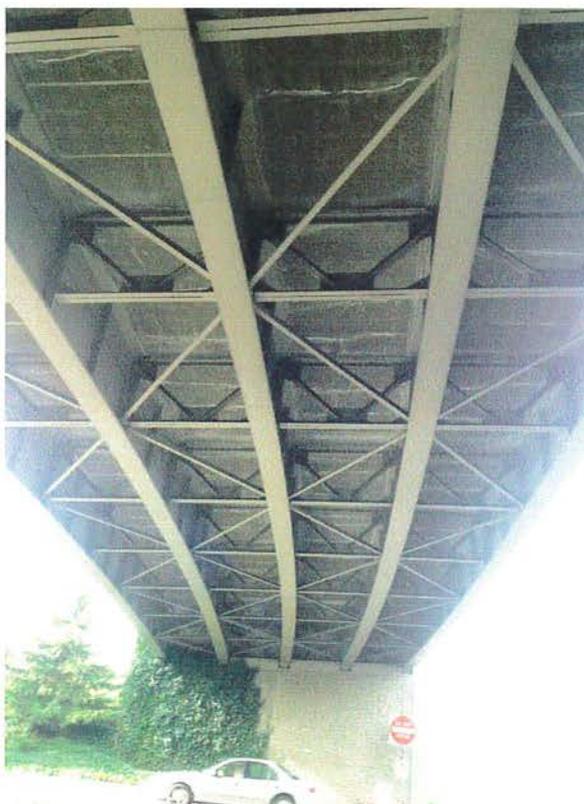
Transverse leaching cracks throughout deck soffit.

Auburn 12 10242014 White Leaching on Soffit Throughout

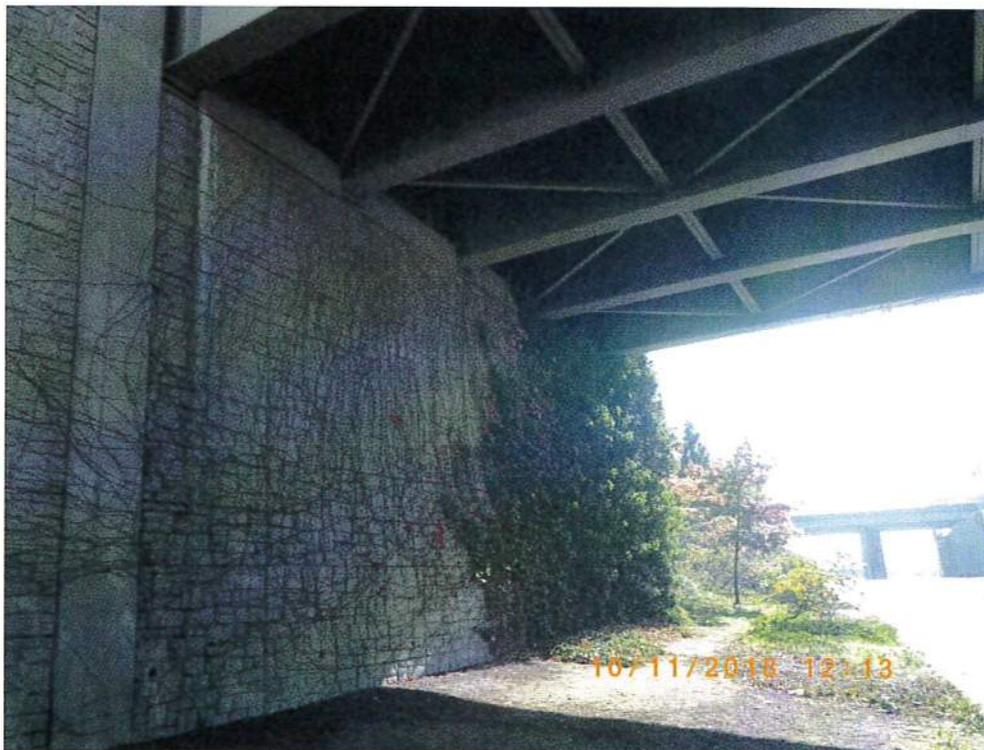
REMARKS: Abutment 2

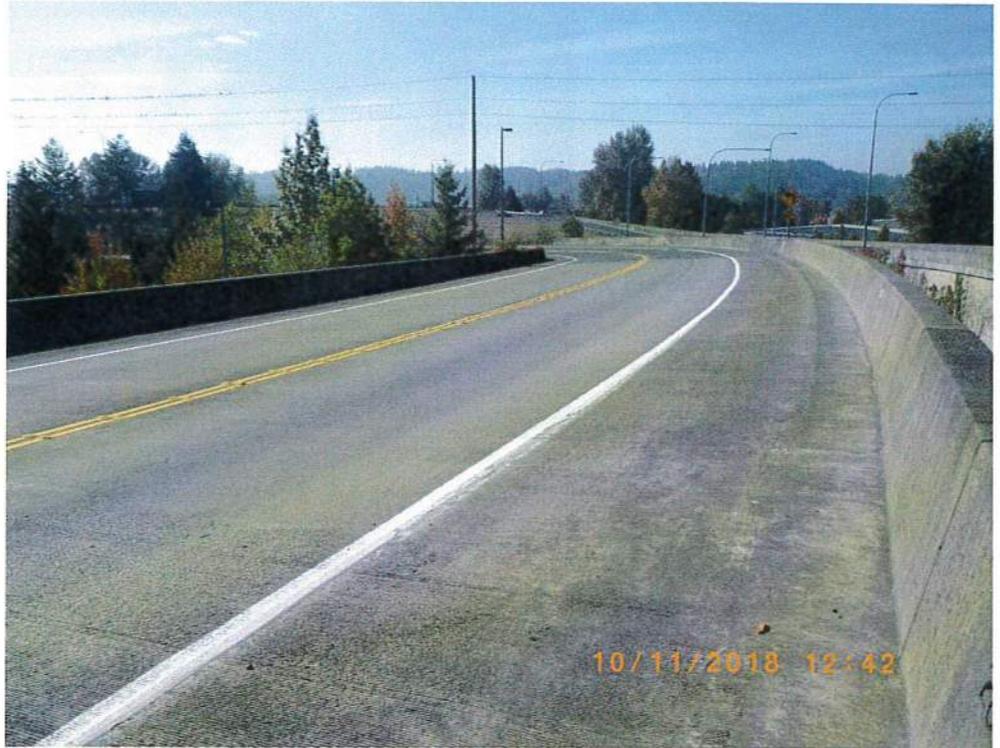
REMARKS: Top of deck

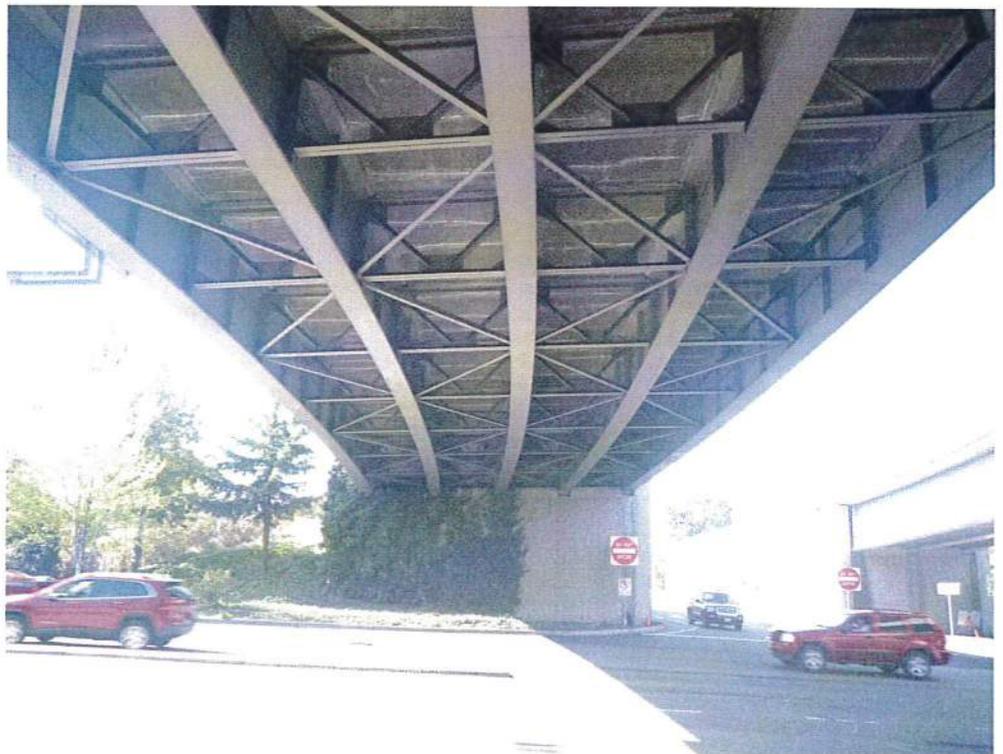
PHOTO
AUBURN12_10-11
-2018_HP (9)
ABUT 1

REMARKS: Abutment 1

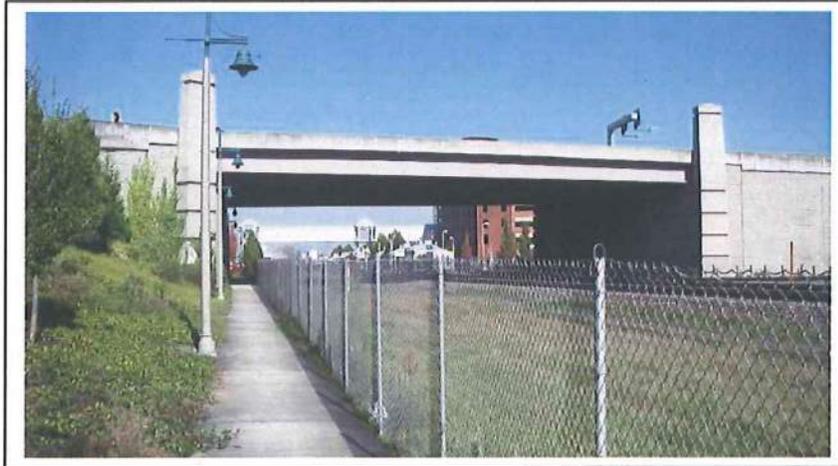
Elevation view looking north from pedestrian trail.

Vertical cracks in both abutment walls; many are full length.

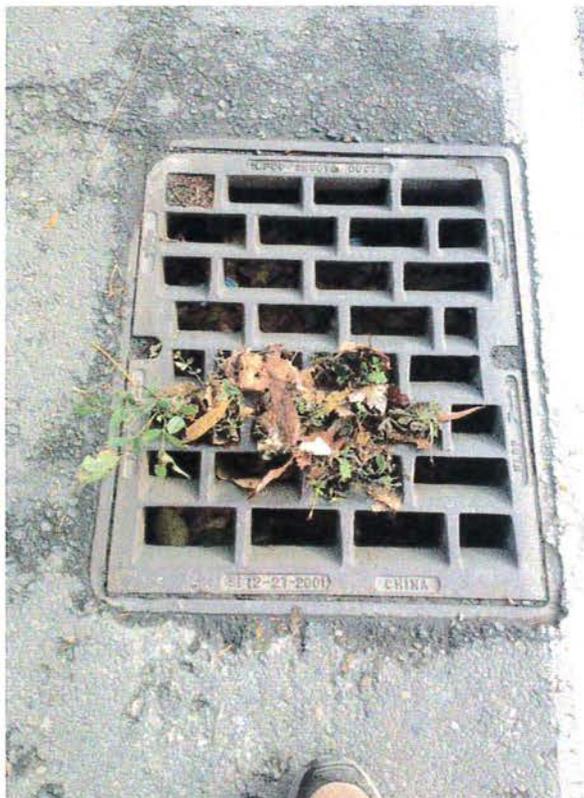
Auburn 13 10242014 Drainage Clogged

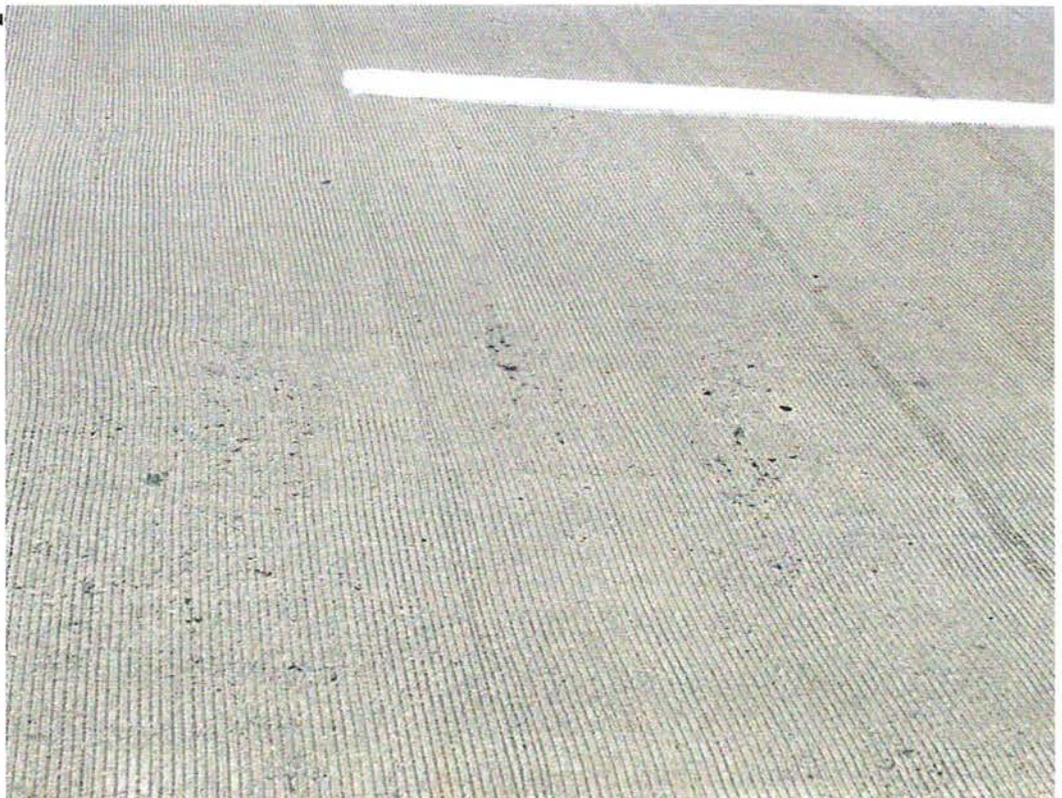
Auburn 13 10242014 Mud Ball Voids Throu

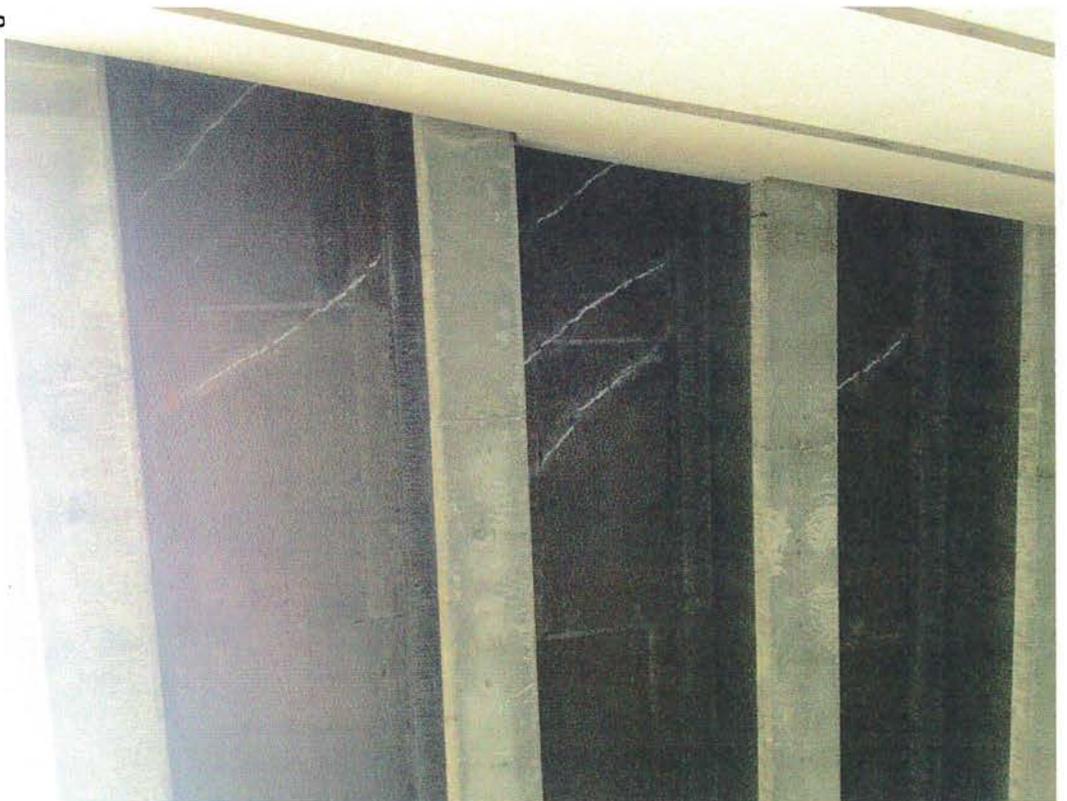
Auburn 13 10242014 White Leaching on So

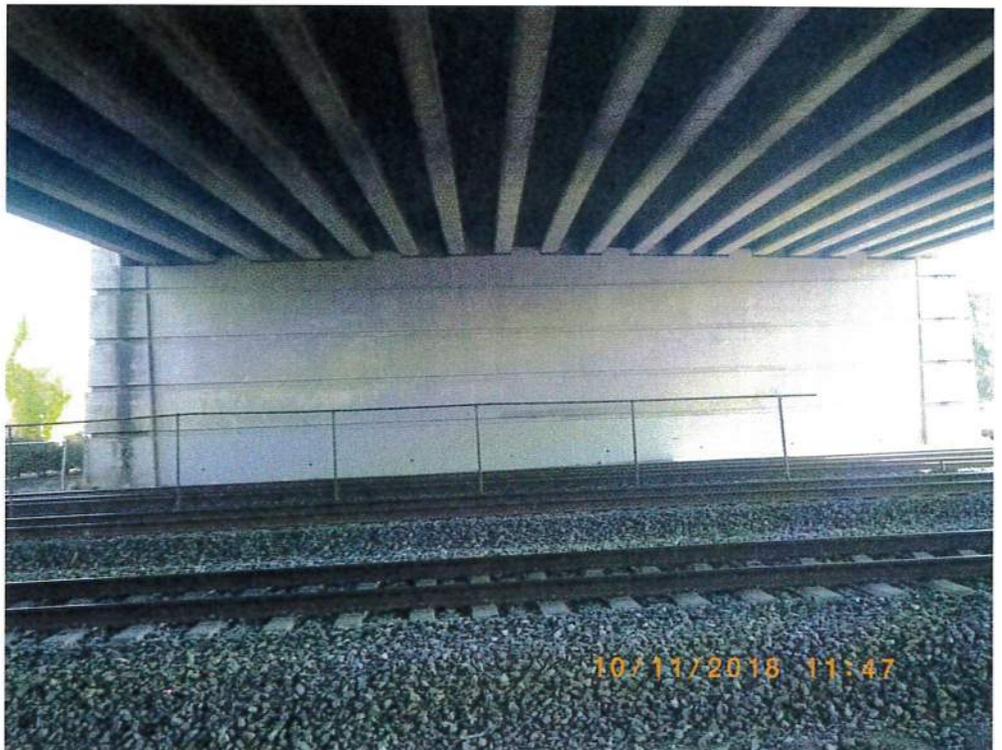
REMARKS: Abutment 2
